Assessment of Coastal Processes Affecting Beach Morphology at Sandy Point State Park, MD

Midshipman 1/C Garrett L Barrios and Midshipman 1/C Gage A Butler, USN, Class of 2018

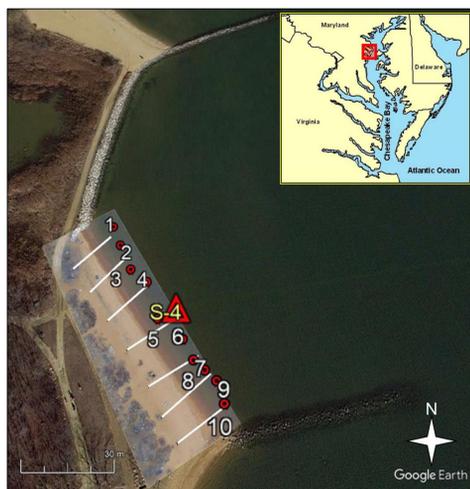
Figure 1. Map of study area at Sandy Point State Park, MD located on the western shore of the mesohaline Chesapeake Bay just north of the Chesapeake Bay Bridge. Shaded area is an ortho-mosaic created from an aerial drone survey on 27 March 2018. White lines are beach survey transects. The red triangle indicates the location of deployment of an S-4 current meter from 16-27 February 2018 and red dots (1-10) are locations of sediment samples collected on 16 February 2018.

A beach study was conducted from February – March 2018 on a small (~ 300 m), low-energy, northeast facing (approx. 045°) beach between two groins at Sandy Point State Park, MD (Fig. 1). On 16 February an S-4 current meter was deployed to collect current data ~ 10 m offshore on an aluminum mount ~ 1 m off the seabed (Fig. 2A). Sediments were collected from 10 points (1-10; Fig. 1) north-to-south just landward of the shoreface (Fig. 2B). Sediment samples were dried in the lab at 60 °C for > 48 hours and analyzed for grain size (in 6 classes) using dry mechanical sieving (USGS, Poppe *et al.*, 2000). The S-4 was recovered on 26 February 2018. An aerial drone survey of the beach was conducted with a DJI Phantom 4 quadcopter on 27 March 2018 using methods of Byers (2017) and processed using Pix4D mapping software. A manual beach survey of 7 lines was performed on 27 March 2018 using a TopCon Laser Alidade and Total Station (Fig. 2C).

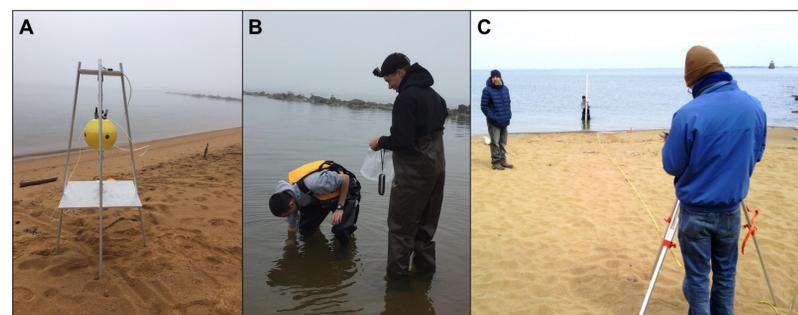
Figure 2. (A) The S-4 current meter with custom aluminum mount on the beach prior to deployment; (B) MIDN 1/C Barrios and MIDN 1/C Butler collecting beach sediments along the shoreface, and; (C) Mr. A. Keppel, Mr. L. Rodriguez, and MIDN 1/C Barrios conducting a beach survey.
