Thermal Damage behind HEL-Irradiated Carbon Fiber–Reinforced Polymer Skin

Jorge D. Garcia, Peter Joyce,* and Cody Brownell

United States Naval Academy, Annapolis, Maryland 21402

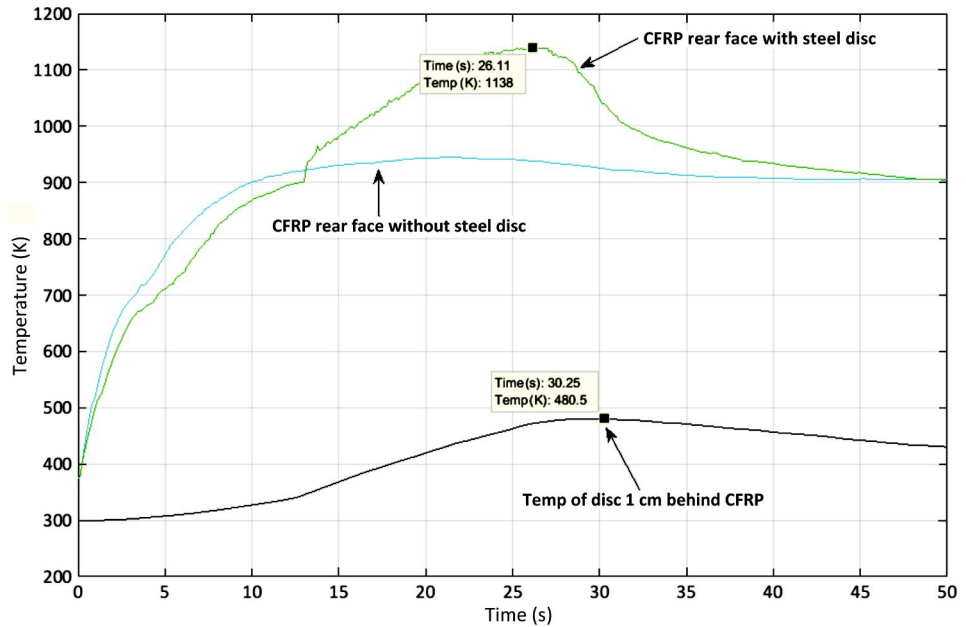
Fig. 10. 305.6 W/cm² without steel disc vs. 305.6 W/cm² with steel disc.

higher temperatures accompanied by flames on the back surface of the composite. As the addition of the steel disc was the only change in the experiment, it was likely reflecting and also radiating heat back to the back surface. This additional heat is what raised the temperature of the resin high enough to initiate flames on the back surface. Fig. 10 compares the IR camera measurements of the 305.6 W/cm² test without a steel disc to the 305.6 W/cm² test with the steel disc. The excess heating due to the presence of the steel disc is clearly visible and corresponds to the back face flames recorded by the IR camera between approximately 12 s and 25 s. Once the fuel (resin) was burned off, the temperature of the composite cooled and approached the temperature it had been before the combustion event (~900 K). This temperature was close to the steady-state temperature of the composite tested without a steel disc. This was expected as the test without a steel disc did not involve flames on the back surface. Also shown in Fig. 10 is the temperature of the steel disc, which increased 188 K in 30 s. The peak increase in temperature of the steel disc occurred a few seconds after the back surface of the composite reached its peak temperature.

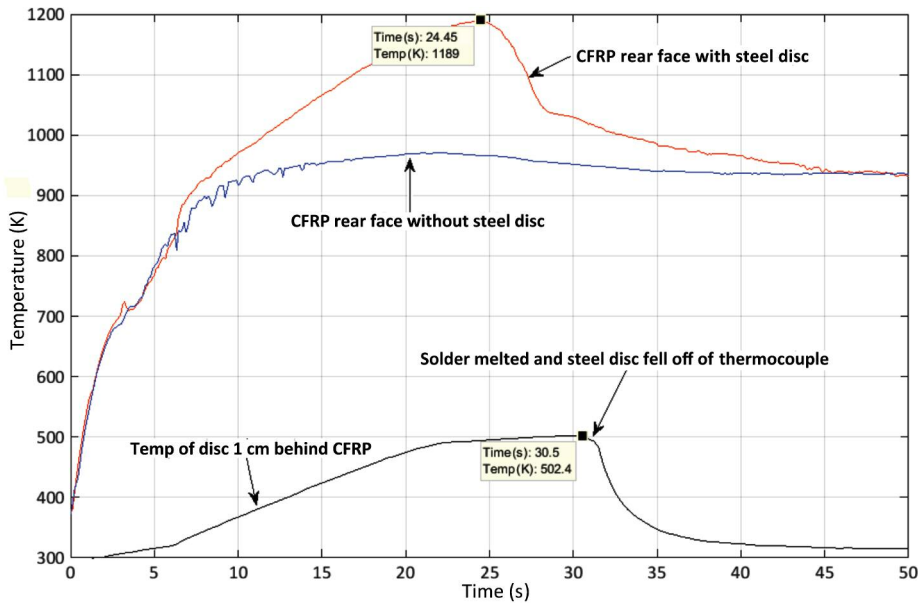
Fig. 12. 356.5 W/cm² without steel disc vs. 356.5 W/cm² with steel disc.

Next, Fig. 12 compares the IR camera measurements of the 356.5 W/cm² test without a steel disc to the 356.5 W/cm² test with the steel disc. As seen in the other tests that incorporated the steel disc, the flames on the back surface resulted in a significant temperature rise. During this test, the composite reached 1189 K after 24.5 s of laser irradiation. This was 223 K greater than the temperature of the composite 24.5 s into the test without the steel disc. Figure 12 also shows a rapid drop in temperature of the steel disc after it reached a peak of 502.4 K. This was because the steel disc was hot enough that the solder connecting

it to the thermocouple melted, causing the steel disc–thermocouple connection to fail. This failure of the internal component illustrates the danger high-energy lasers pose to UAVs whose electronic systems and circuits likely use materials similar to the solder used in this experiment. This also served to validate the thermocouple measurements because the melting point for this type of solder is between 505 K and 511 K.⁹

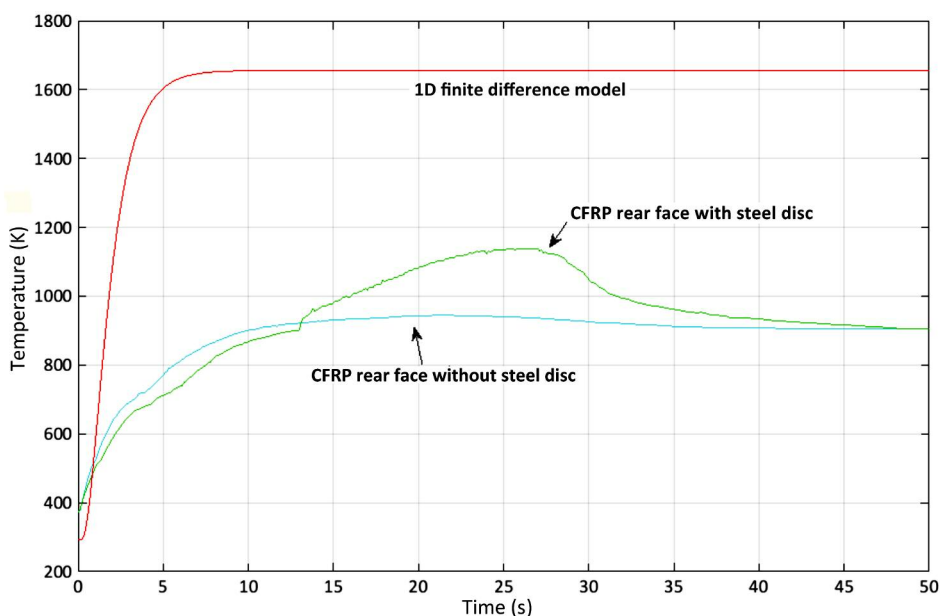
Fig. 15. 1D model vs. experimental results for back surface of 6-ply carbon fiber composite (CFRP) irradiated at 305.6 W/cm^2 .

Figure 15 shows a comparison of the experimental and model results for 305.6 W/cm^2 . As shown in the figure, the 1D finite difference model did not agree with the experimental results. This model assumed that heat flowed in one direction through the composite and parallel to the incoming radiation, but it did not account for heat flowing along the fibers and perpendicular to the incoming radiation. Furthermore, this model did not take into account changing material properties of the carbon fiber composite. When subject to intense heating,

material properties such as specific heat, translucence, and thermal conductivity can change significantly. In addition, during heating the resin is burned out of the composite and the fibers begin to oxidize, certainly changing the material properties. Finally, during the tests the thickness of the composite in the irradiated area was changing as fibers were oxidized, ejected, and occasionally fell out due to structural instability. Although the model did not agree with the back face temperatures measured at U.S. Naval Academy (USNA), it was possible that the back face IR temperature measurements were not accurate. To investigate this, further tests were conducted during which IR camera measurements were compared to temperatures measured by fiber Bragg grating (FBG) sensors embedded in a thin carbon-fiber composite.

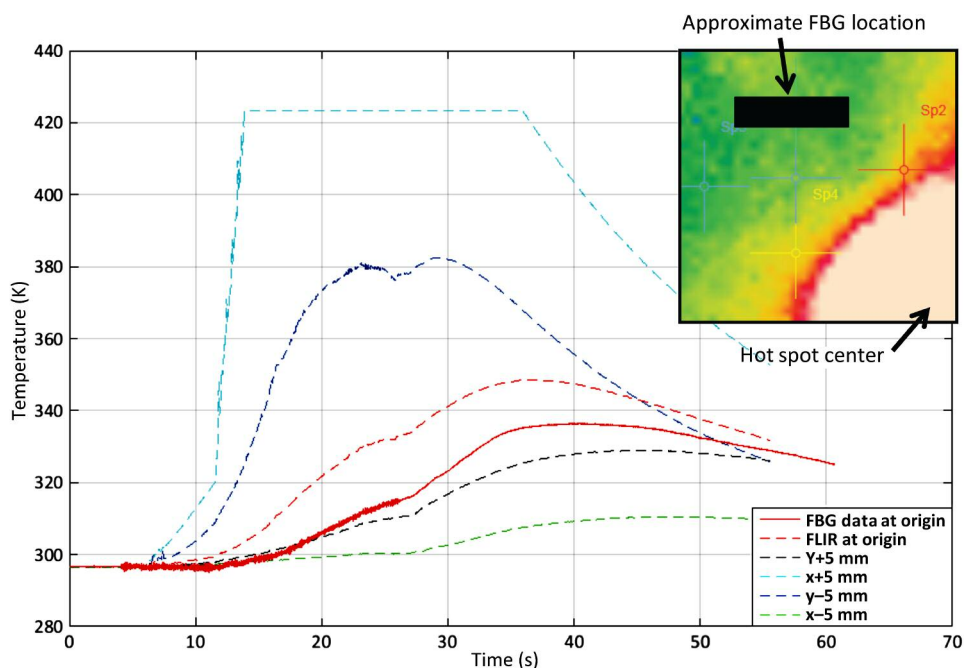
Fig. 18. First FBG comparison to IR data.

Figure 18 shows the results from the first FBG test during which the laser was aimed below and to the left of the sensor. An IR image of the back face of this figure. During these tests, a CFRP emissivity value of 0.95 was used. The IR camera was set on the low temperature calibration range for this first test. The cursors shown on the right side of Fig. 18 measured the temperature in five locations that were near the estimated position for the FBG. The center cursor was called the “FLIR at origin” curve, with the other measurements being taken within 5 mm of that spot. Multiple measurements of the area of interest were taken because there was some uncertainty about the exact location of the FBG sensor. During this test, the IR camera was set to its low temperature range and did not record temperatures above approximately 420 K. This explains the plateau shape of the “ $x + 5$ mm” curve shown in Fig. 18. The large spatial temperature gradient on the CFRP accentuates the importance of alignment between the FBG sensor and the image interrogation window. Fortunately, time histories of the temperature data can be used as a secondary indicator of position. Due to the transient nature of the laser strike, different positions on the CFRP reach peak temperature at different times. By looking at correlations of the time–temperature data at various interrogation windows, the proper location of the FBG within the IR camera image was confirmed. Fig. 18 shows that the FBG measurements from the back layer served to validate the IR temperature data, as the “ $y + 5$ mm” temperatures were close to the “FBG data at origin” temperatures. Changes in the location of the cursor had a much more significant effect on the measured temperature than the assumed emissivity value.

Two other observations vis-à-vis Fig. 18 are noteworthy. The “noise” in the FBG data is due to vibrational strains induced in the composite by the N_2 gas used to suppress

combustion. The noise is eliminated at 25 s when the N_2 gas is turned off and the vibrations stop. But the temperature of the composite continues to rise, especially for locations in the IR image farthest from the hotspot, which is due to the relatively low thermal conductivity of the CFRP. The through-thickness FBG sensors exhibited similar temperature responses in the front and middle planes throughout the laser strike.

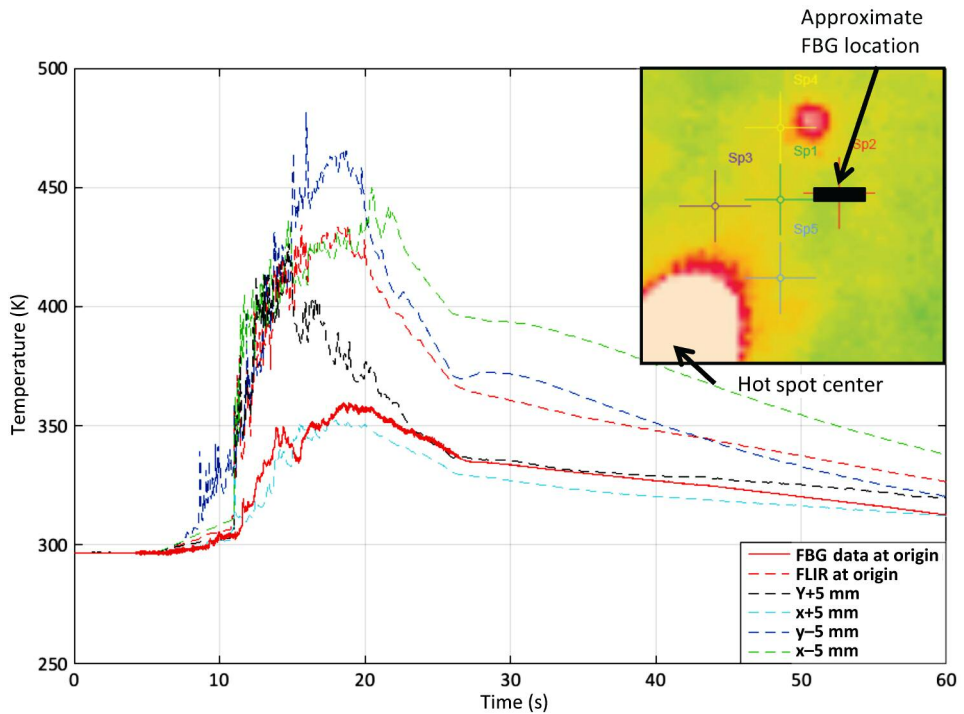
Fig. 19. Second FBG comparison to IR data.

Figure 19 shows results from the second FBG test during which the laser was aimed below and to the right of the sensor. The laser power was reduced to 20 W (effective irradiance of 100 W/cm^2) and the IR camera was set on the mid-range temperature calibration for this second test; hence the more sensitive temperature results compared to the first test (Fig. 18). Temperatures recorded by the FBG in the second test (Fig. 19) are slightly higher than those of the first test (Fig. 18) because the flames were directed away from the FBG by the vacuum in the first test. As with the previous test, there was some uncertainty concerning the exact location of the FBG sensors relative to the laser spot. Fig. 19 shows that the “ $x + 5 \text{ mm}$ ” temperatures were in best agreement with the “FBG data at origin” temperatures recorded by the sensor in the back layer.
