# Damage Control

Presented By:  
*Steve D'Antonio*

Steve D'Antonio  
Marine Consulting, Inc.

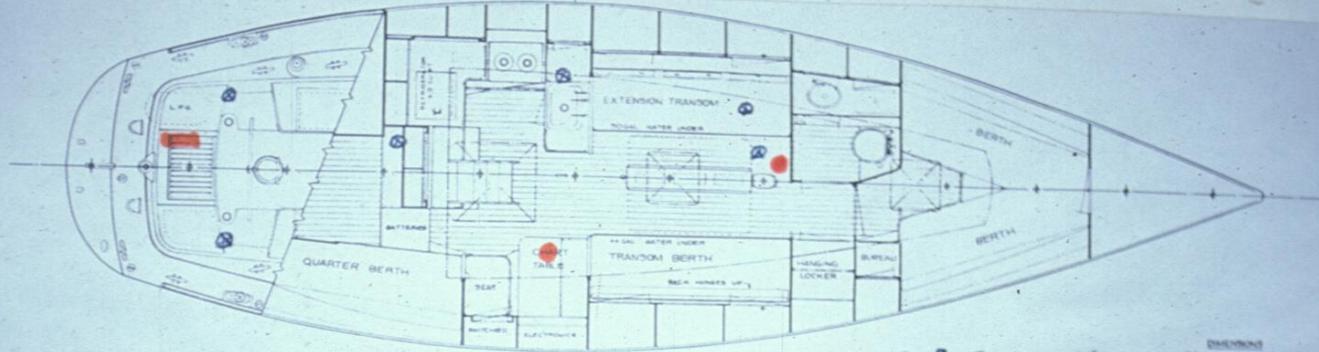
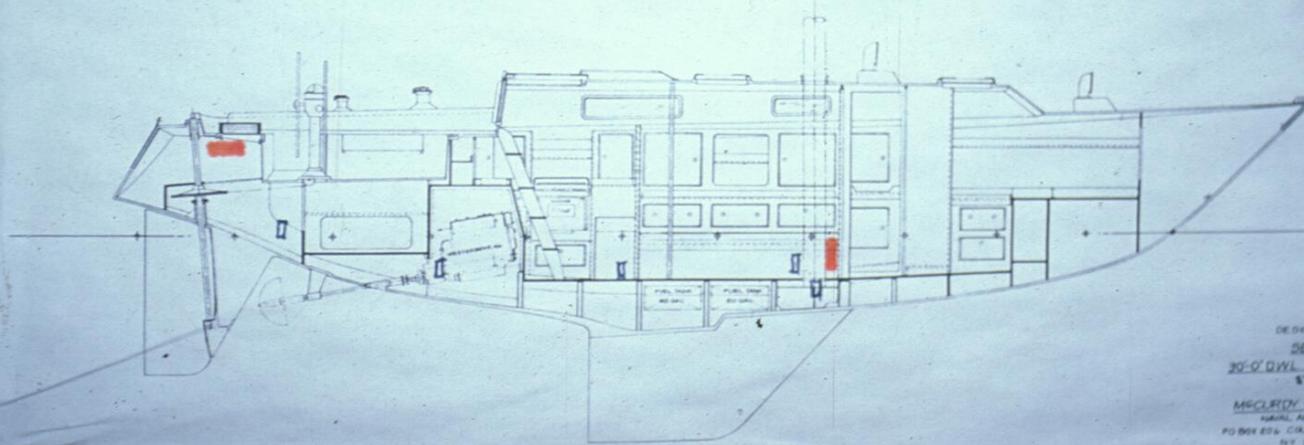
# Post a Seacock Location "Map"

⊗ □ SEACOCK

● ■ FIRE EXTINGUISHERS

DIMENSIONS	
L.O.A.	36'-0"
BEAM	11'-0"
DEPT.	5'-0"
DRAFT	2'-0"

DESIGN NO. 84  
SELKIE  
20'-0" DWL. F.R.P. CUTTER  
8'-11" H  
MCGURDY & RHODES, INC.  
NAVAL ARCHITECTS  
PO BOX 874, COLD SPRING HARBOR  
NY 11724

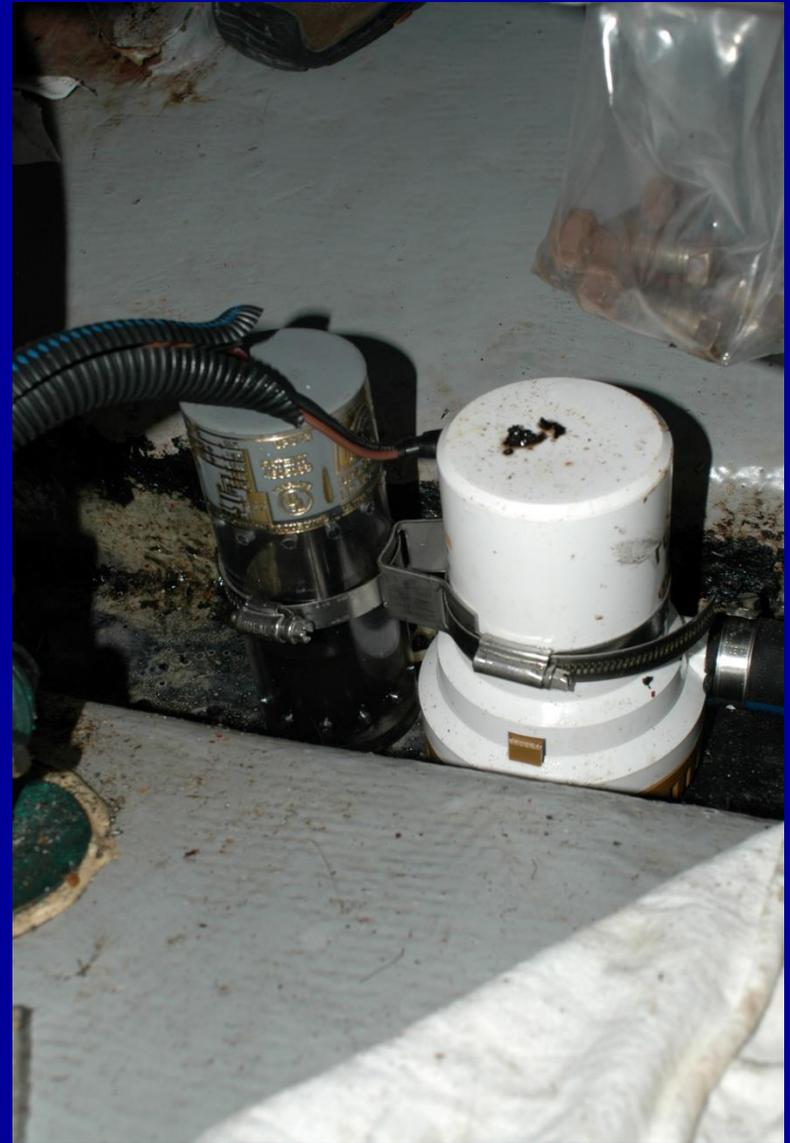
# Bilge Pumps

- *Larger electric bilge pumps are typically in the 1500-2000 GPH range, under ideal conditions.*
- *Actual is often half rated capacity*

Rule of thumb: 100 gallons/hour for every foot of boat length

For max capacity submersibles only

Don't forget the alarm

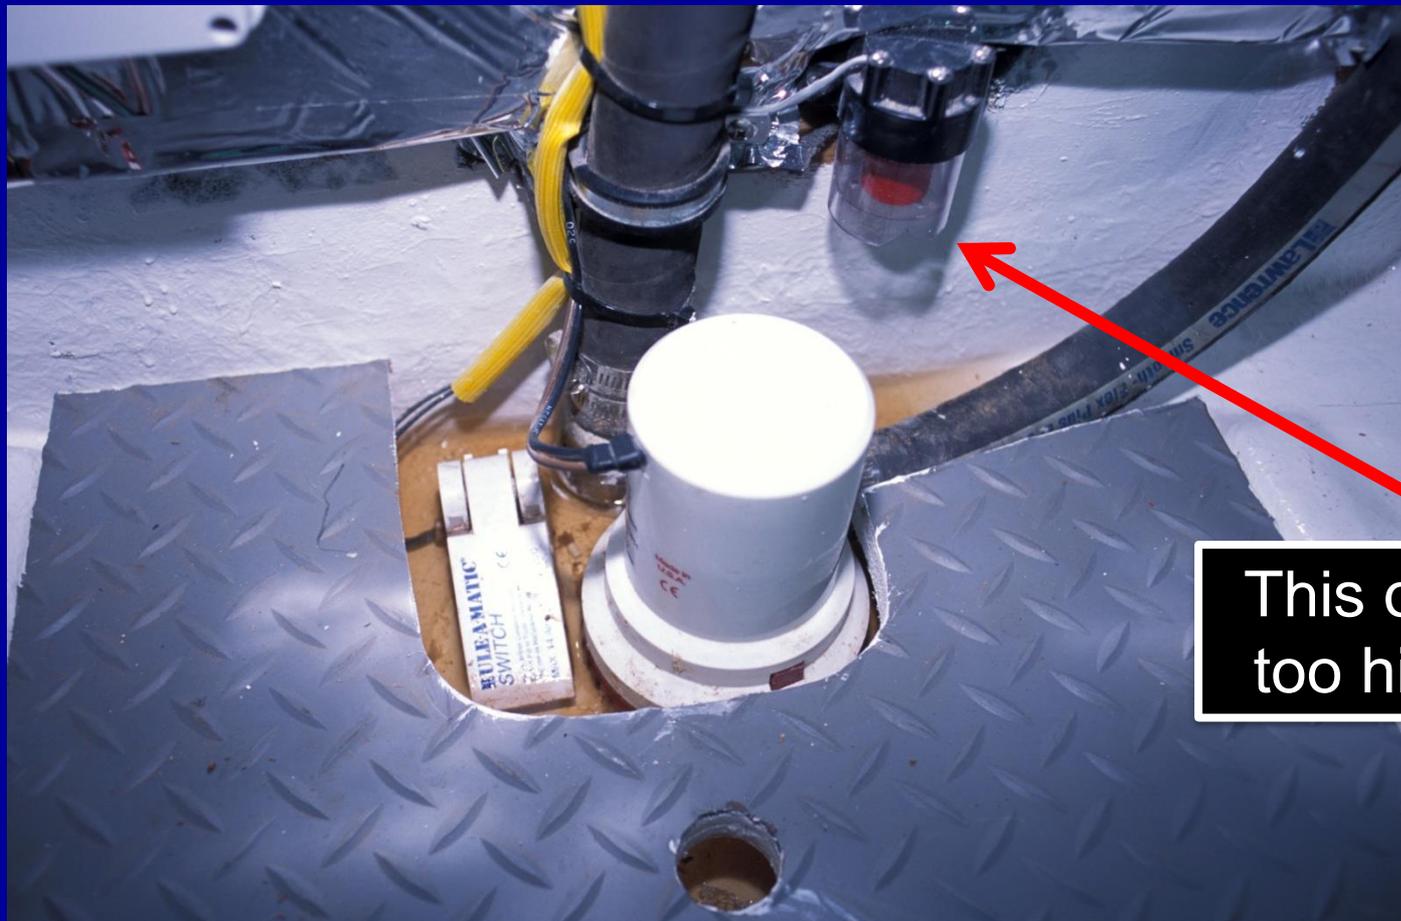
This one is too high...

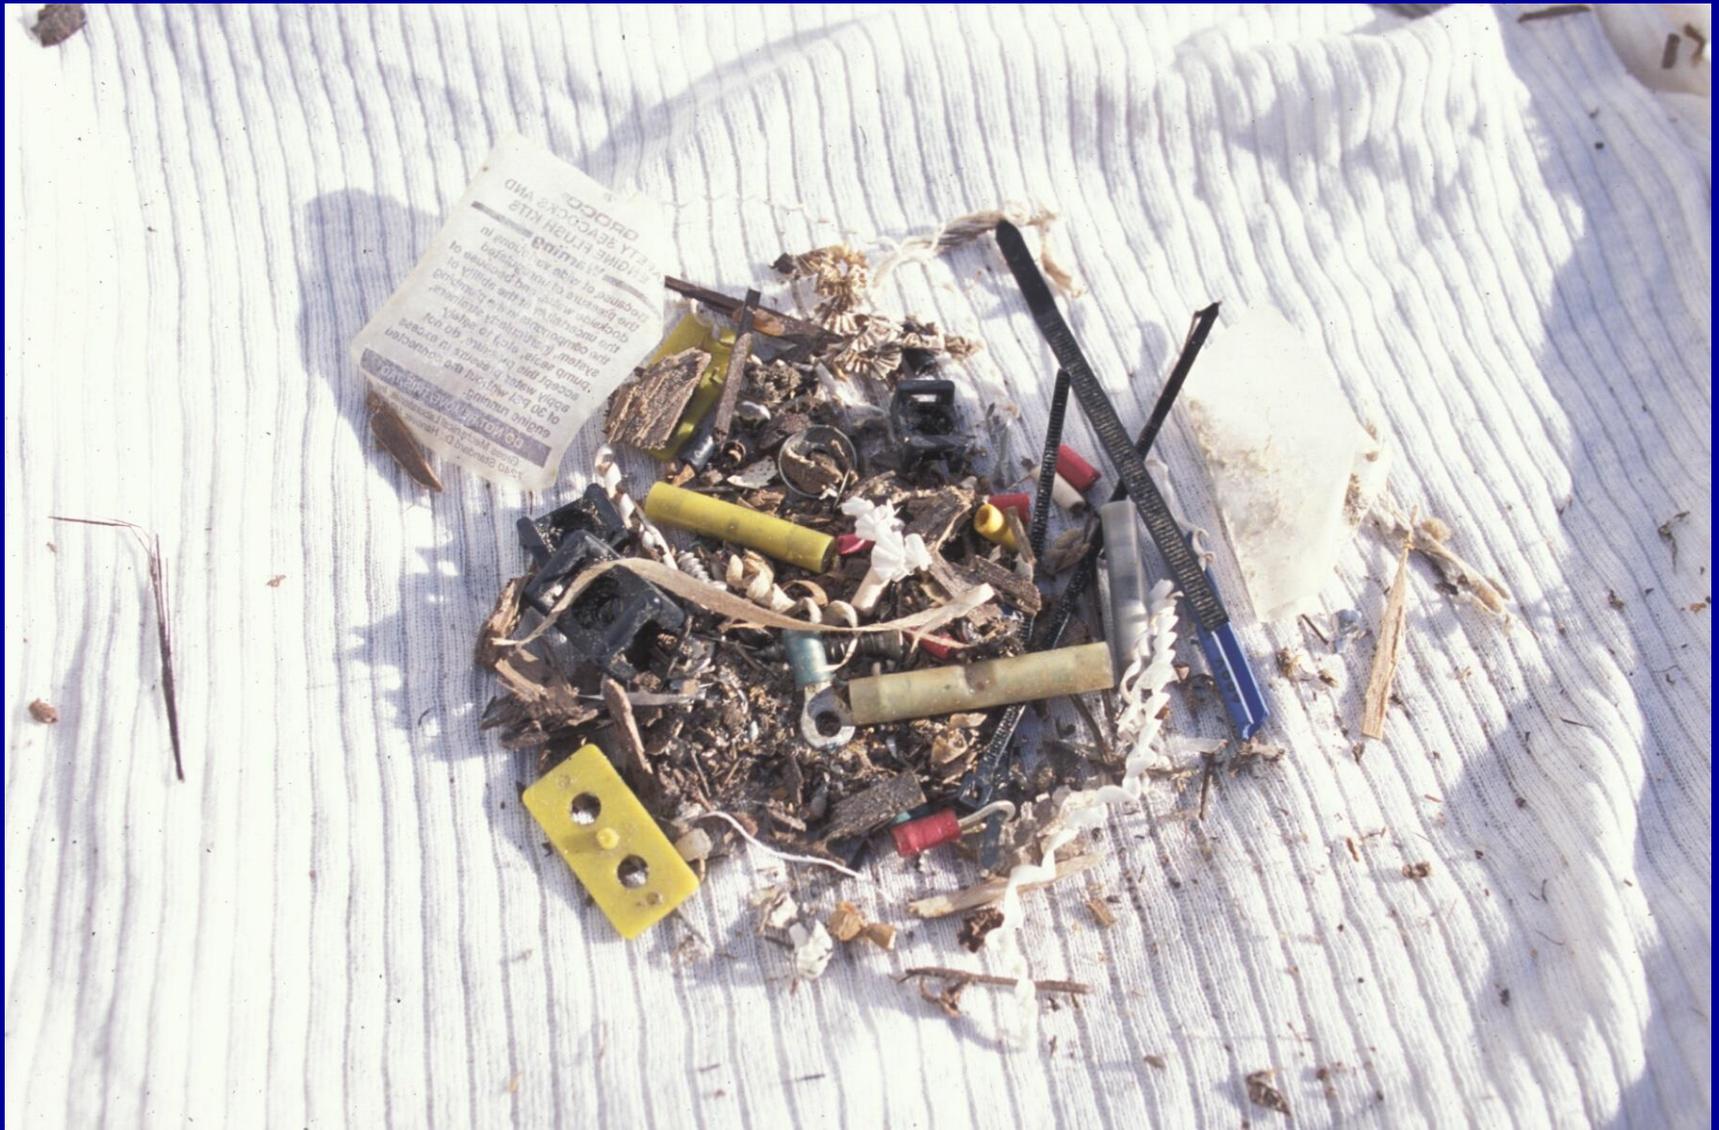
Clean bilges are more than good housekeeping  
Bilge debris is your pump's worst enemy

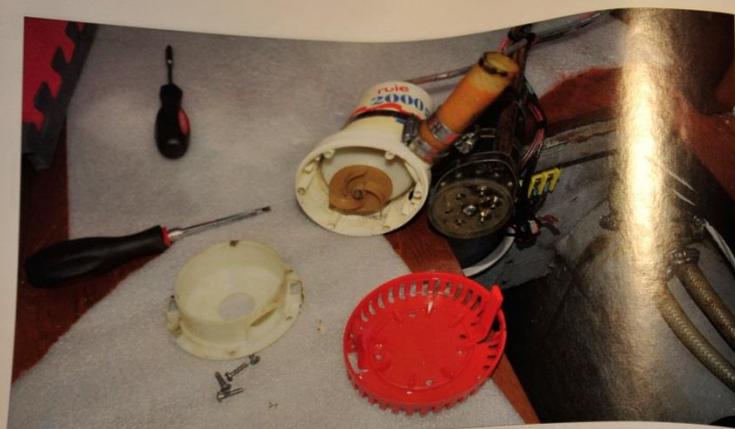
**Above**—A standard 2,000-gph (7,571-lph) centrifugal electric bilge pump and its float switch pulled from the bilge for repairs. As this image illustrates, access to pumps for service is critically important. The most significant thing for a builder or repairer to keep in mind is that even in the best possible situation, this pump is unlikely to actually remove 2,000 gallons of water from the bilge in one hour.

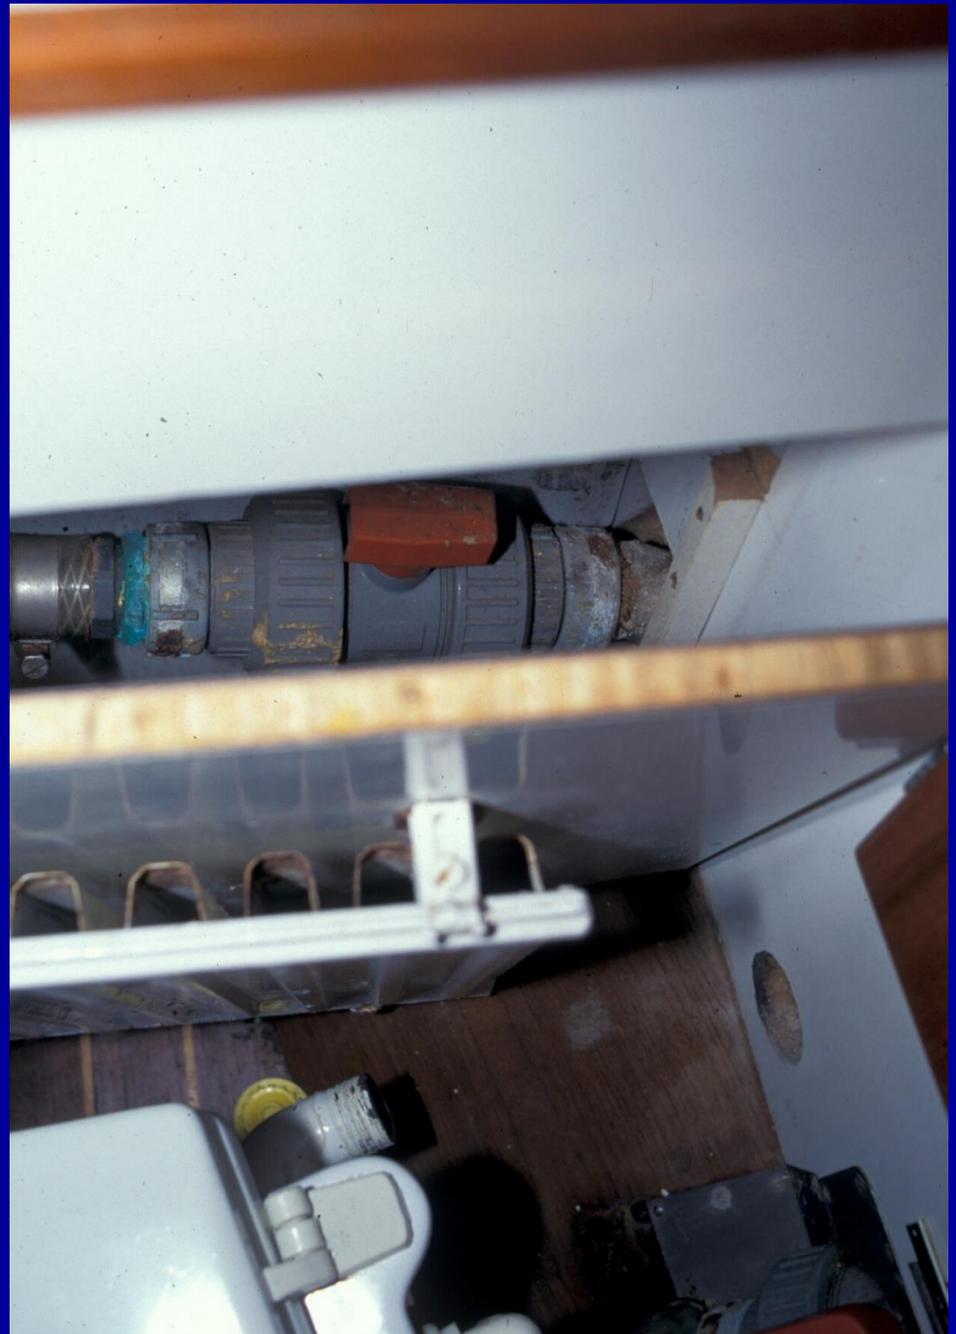
# Avoid the “hidden seacock” syndrome

You should be able to  
find and access every  
seacock aboard your  
vessel, *in total  
darkness...*

...without the aid of  
tools.

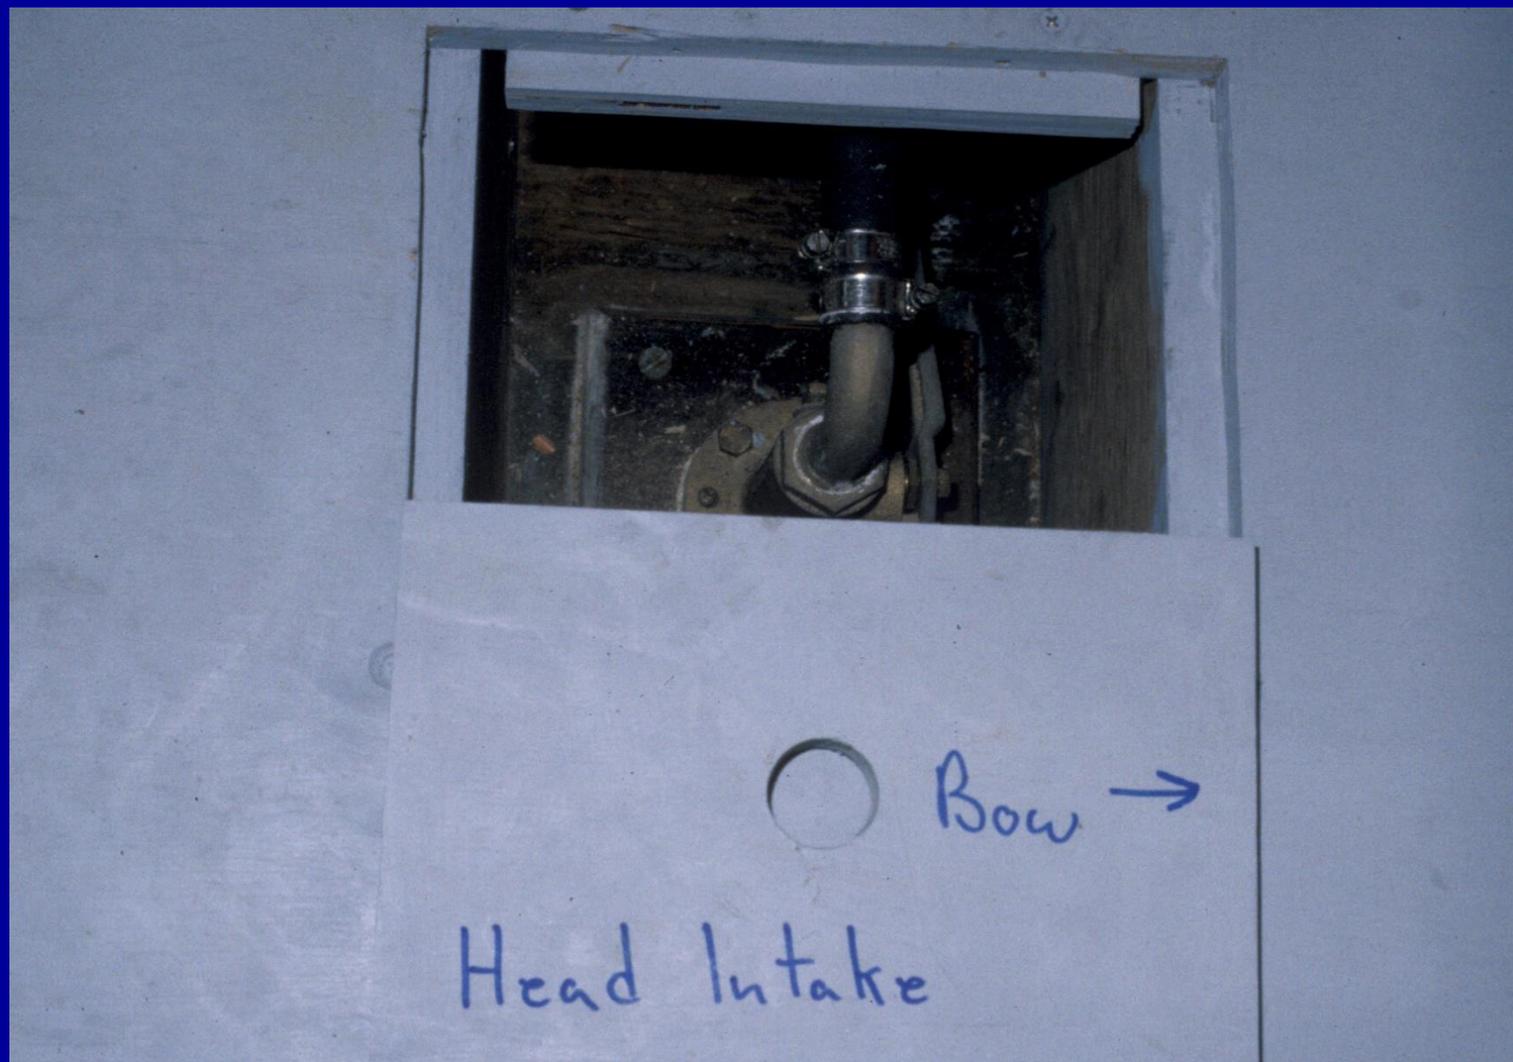
If it's not obvious there's a seacock in there, label it.

○ Bow →

Head Intake

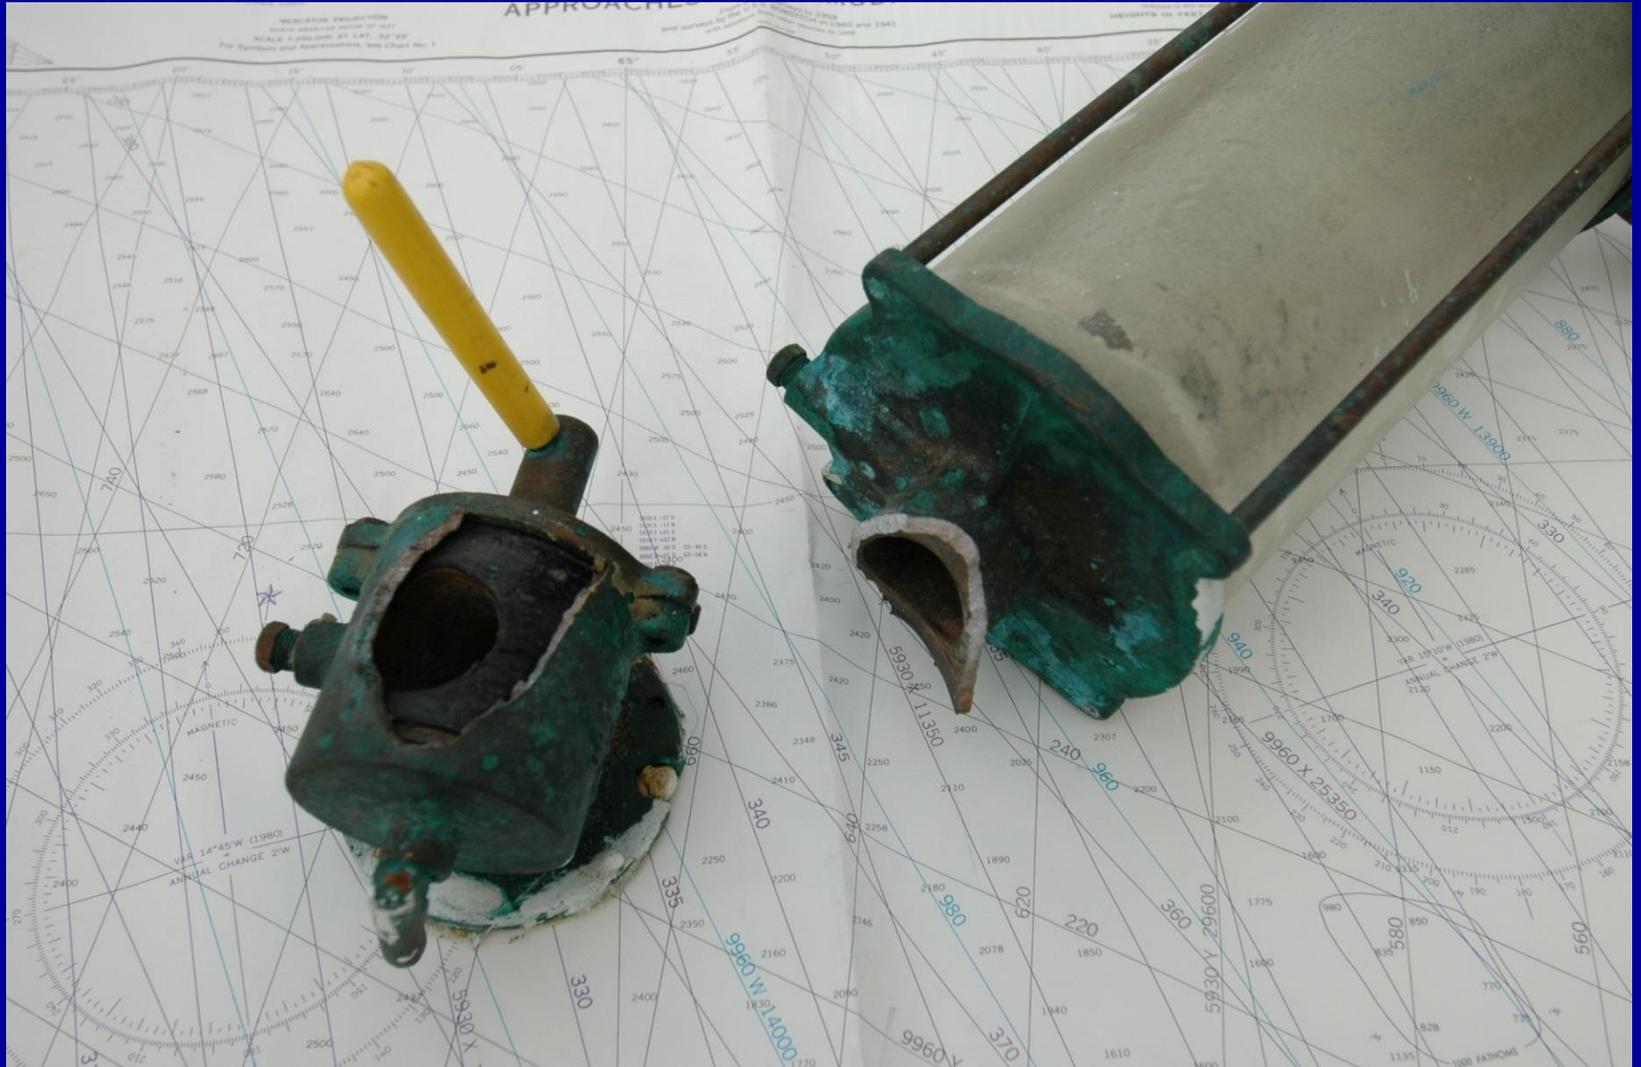
# Avoid leveraging your seacocks

Looks good but...

Not really a  
seacock

Why?

Incompatible  
threads

Lack of a load-  
distributing flange

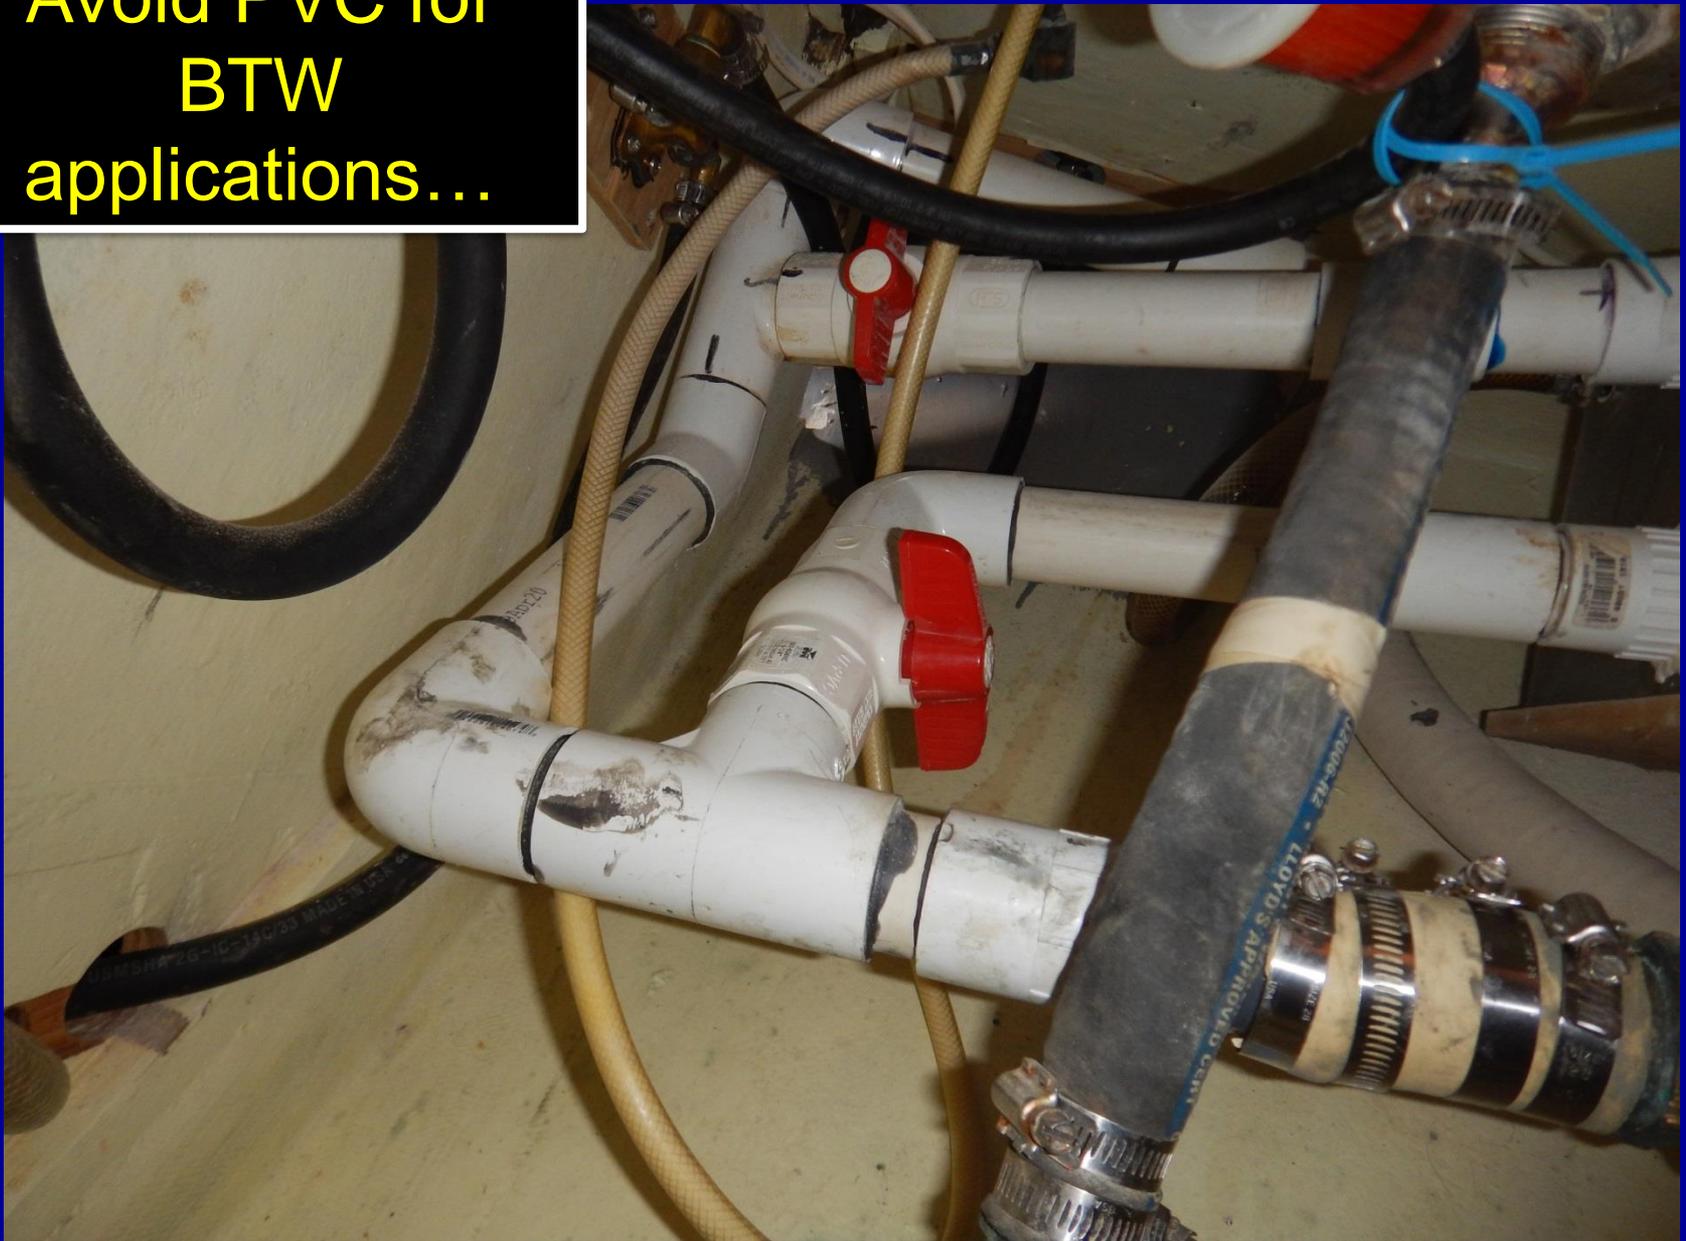
Avoid PVC for  
BTW  
applications...

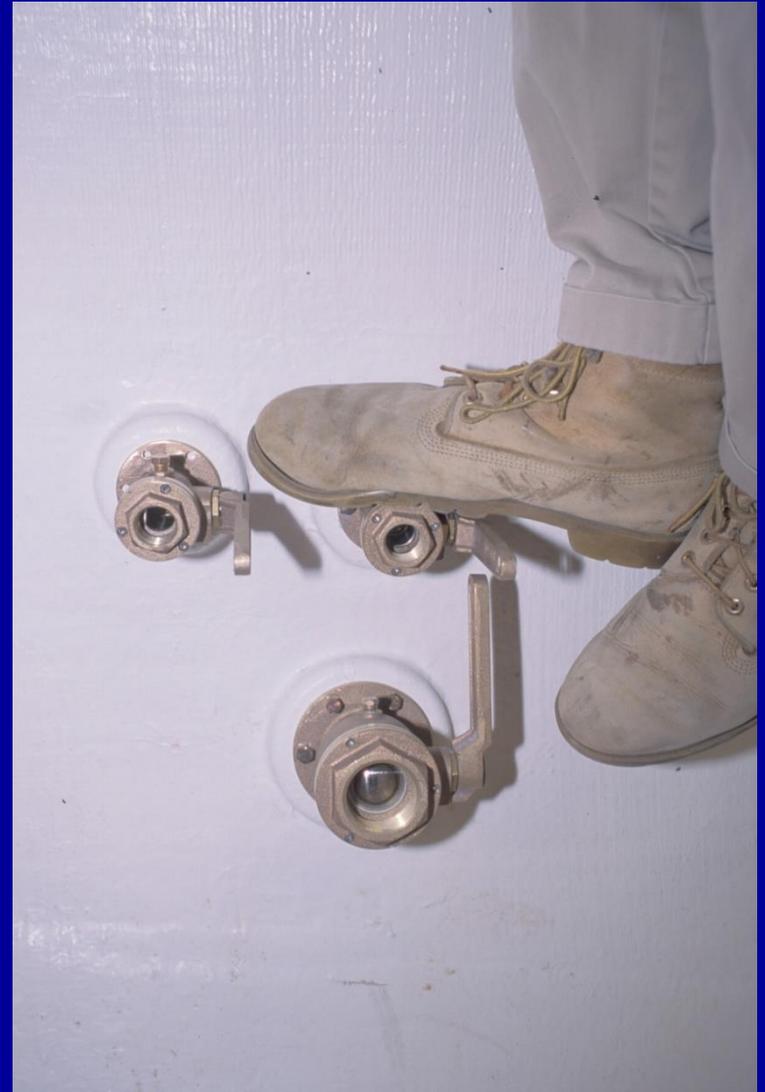
# Seacock Durability and Strength

The ABYC 500  
lb -30 Second  
Rule.

Do yours  
measure up?

The 'stand on it'  
rule

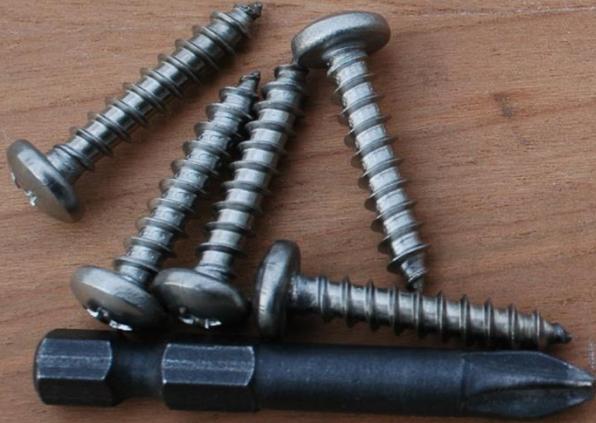
**For FRP/Fiberglass**

**Self Tapping  
Screws**

**Phillips Drive**

**“Cutting Point”  
or PK Screws**

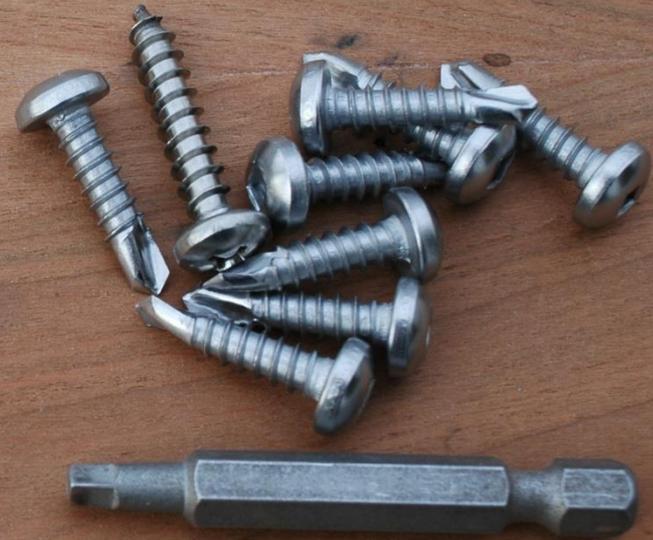
**Square or Robertson  
Drive**

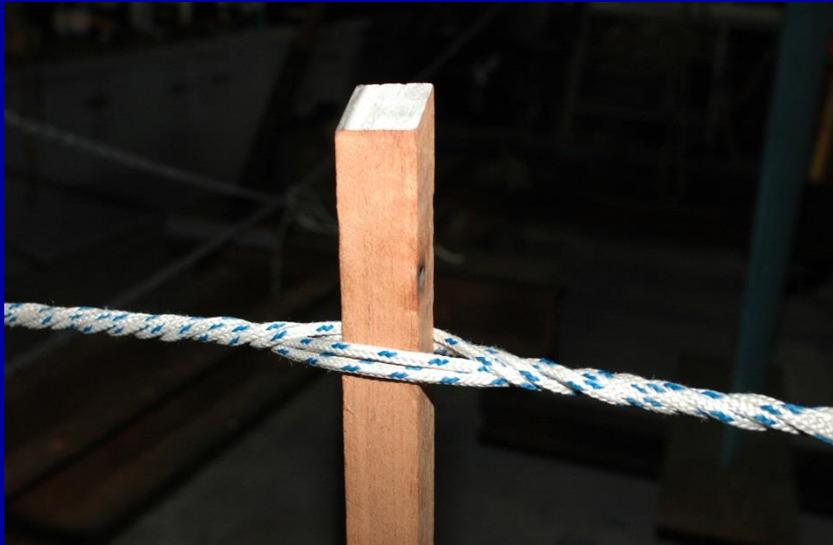
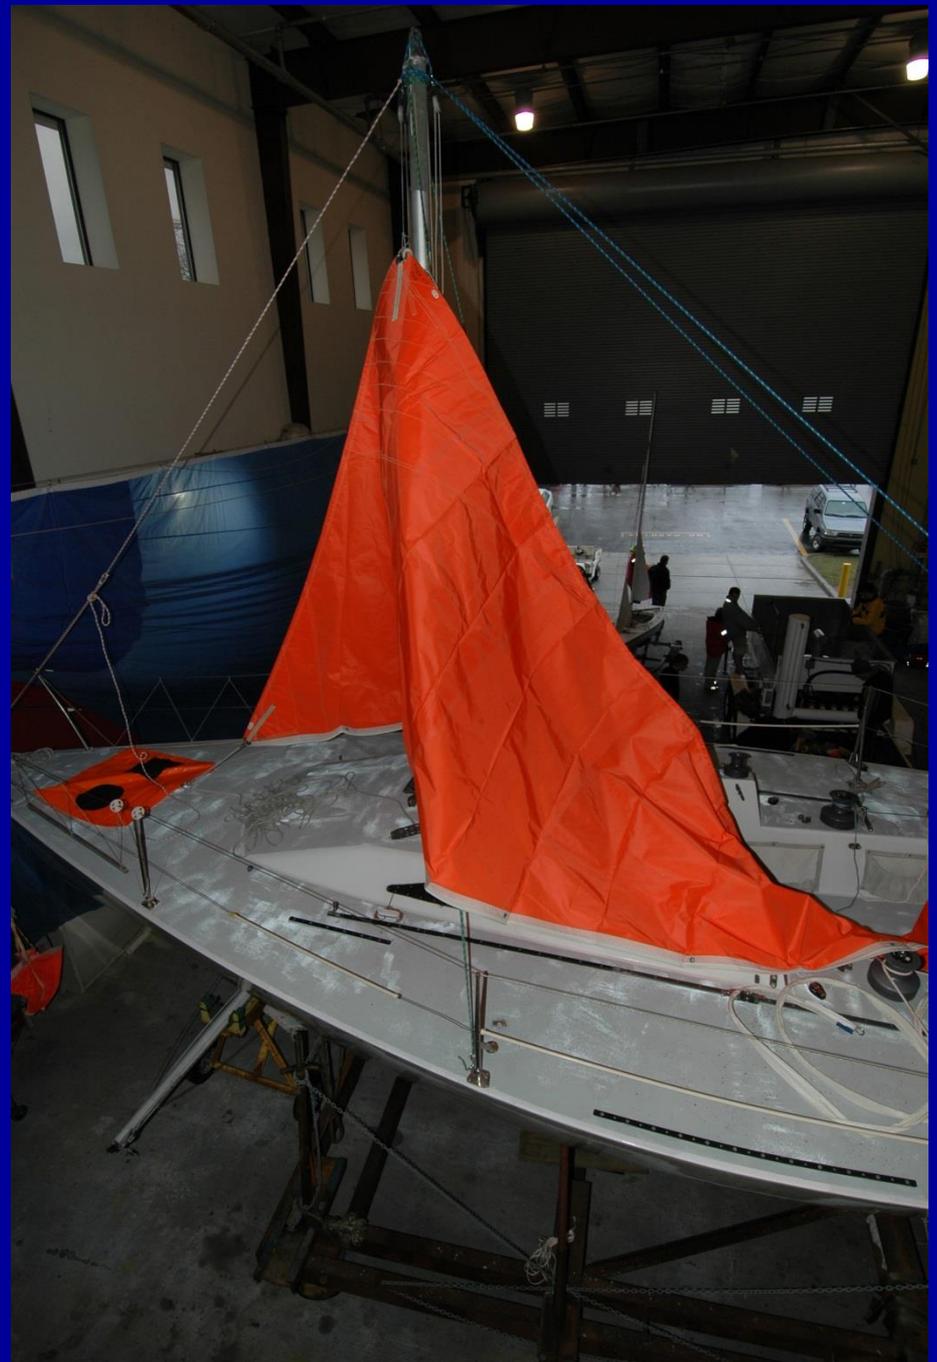
## The Jury Rig

It doesn't have to be pretty...

Think ahead about the parts you might need to make one

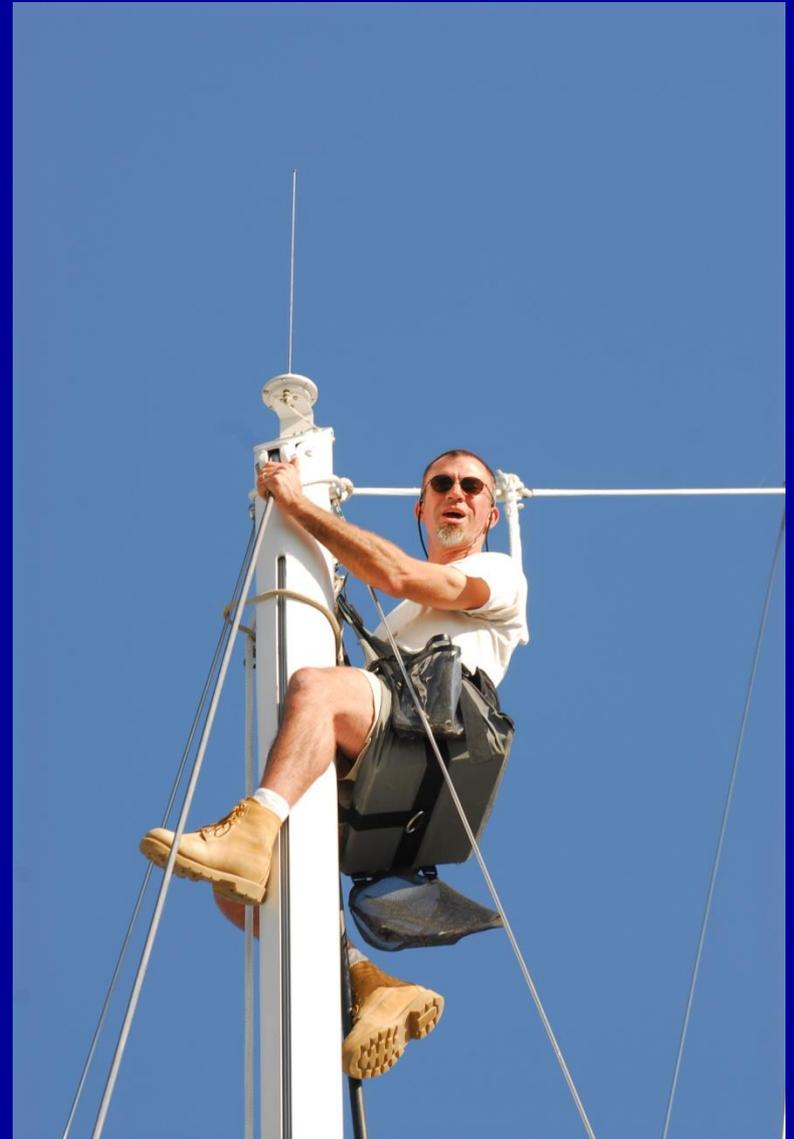
# An Ounce of Prevention...

Conduct regular rig inspections

Go up there

Remove tape and chafe gear

Un-step every 5 yrs/new to you rigs

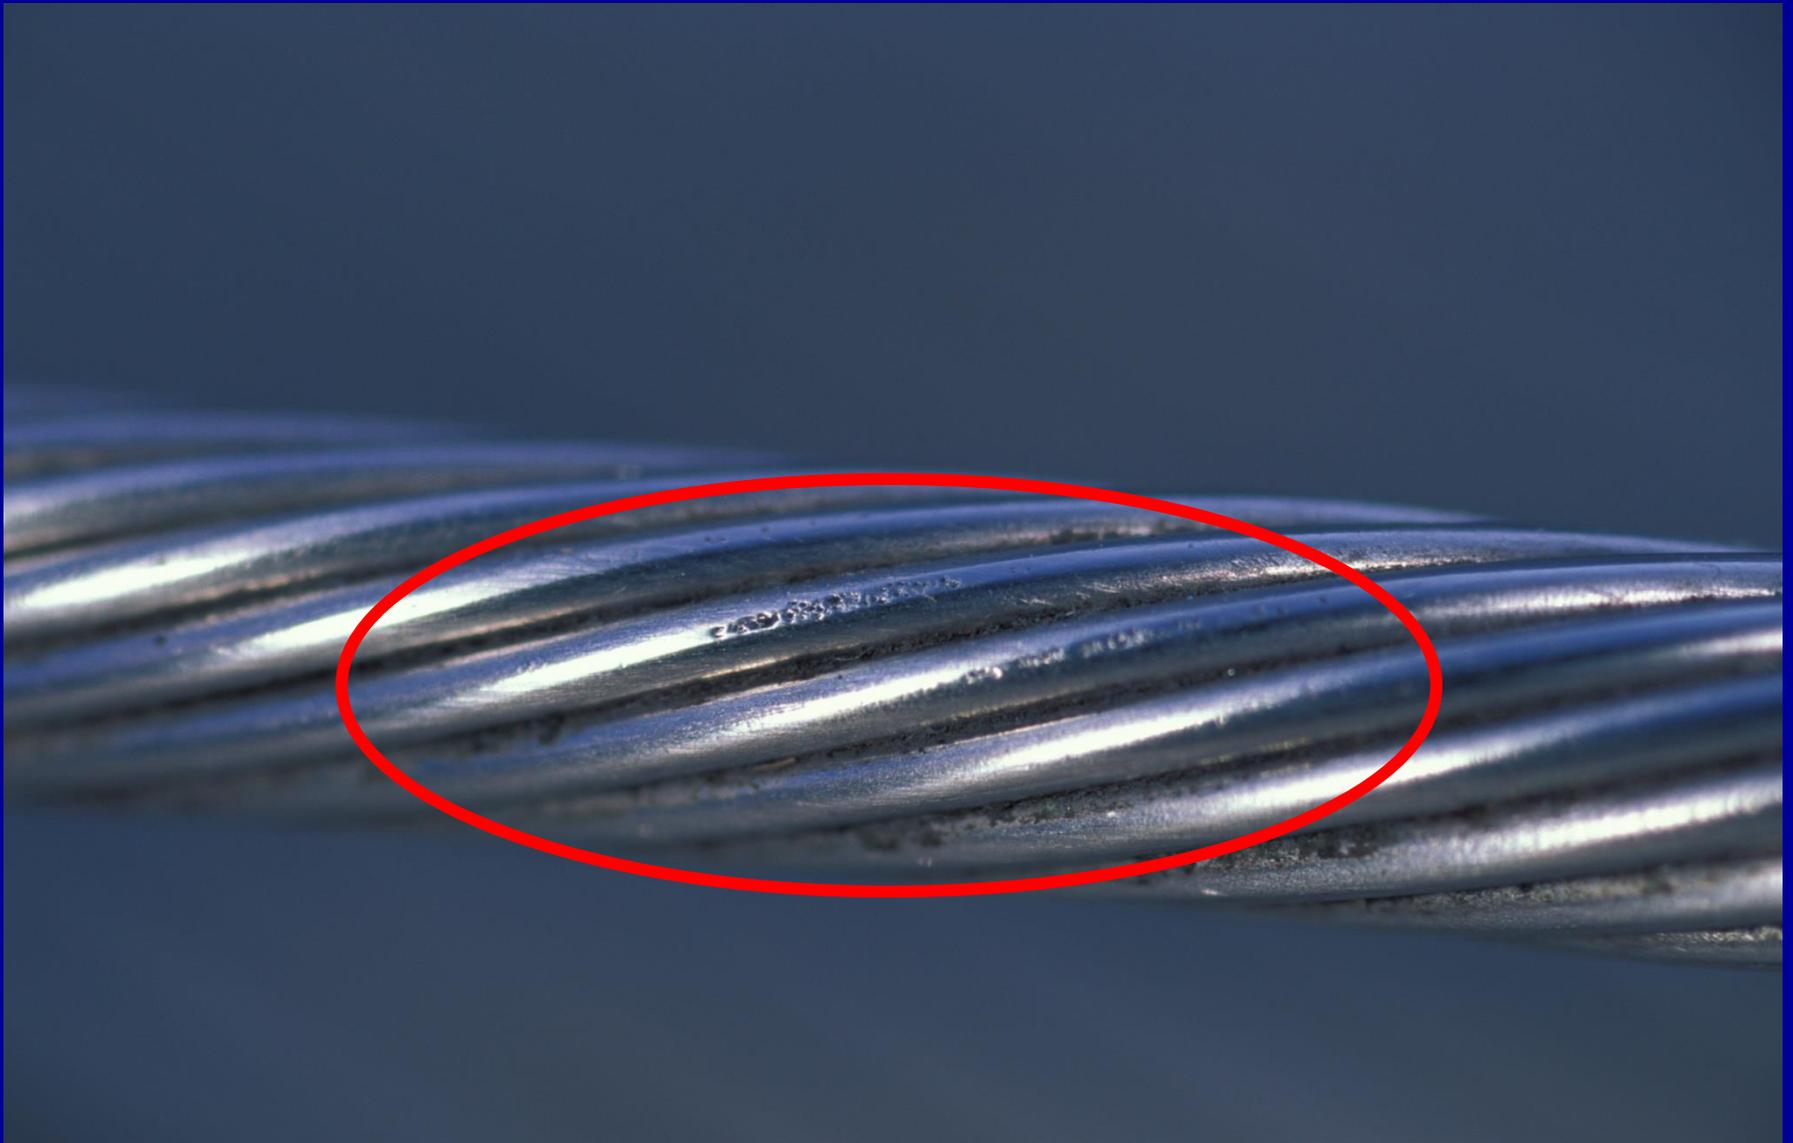
The real damage revealed...

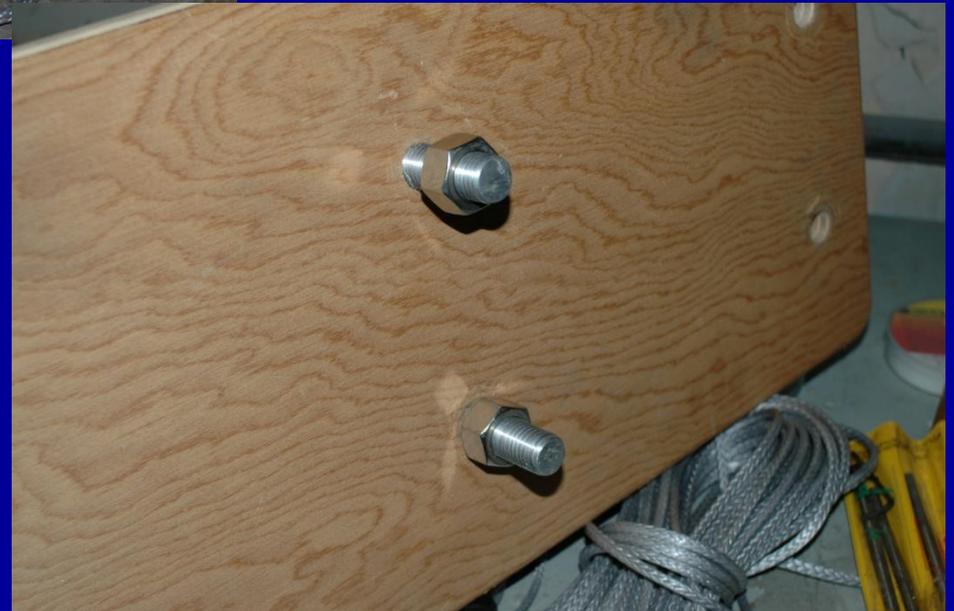
Prepare A Back-Up Rudder In Advance
