# Damage Control

Presented By:  
*Steve D'Antonio*

Steve D'Antonio  
Marine Consulting, Inc.

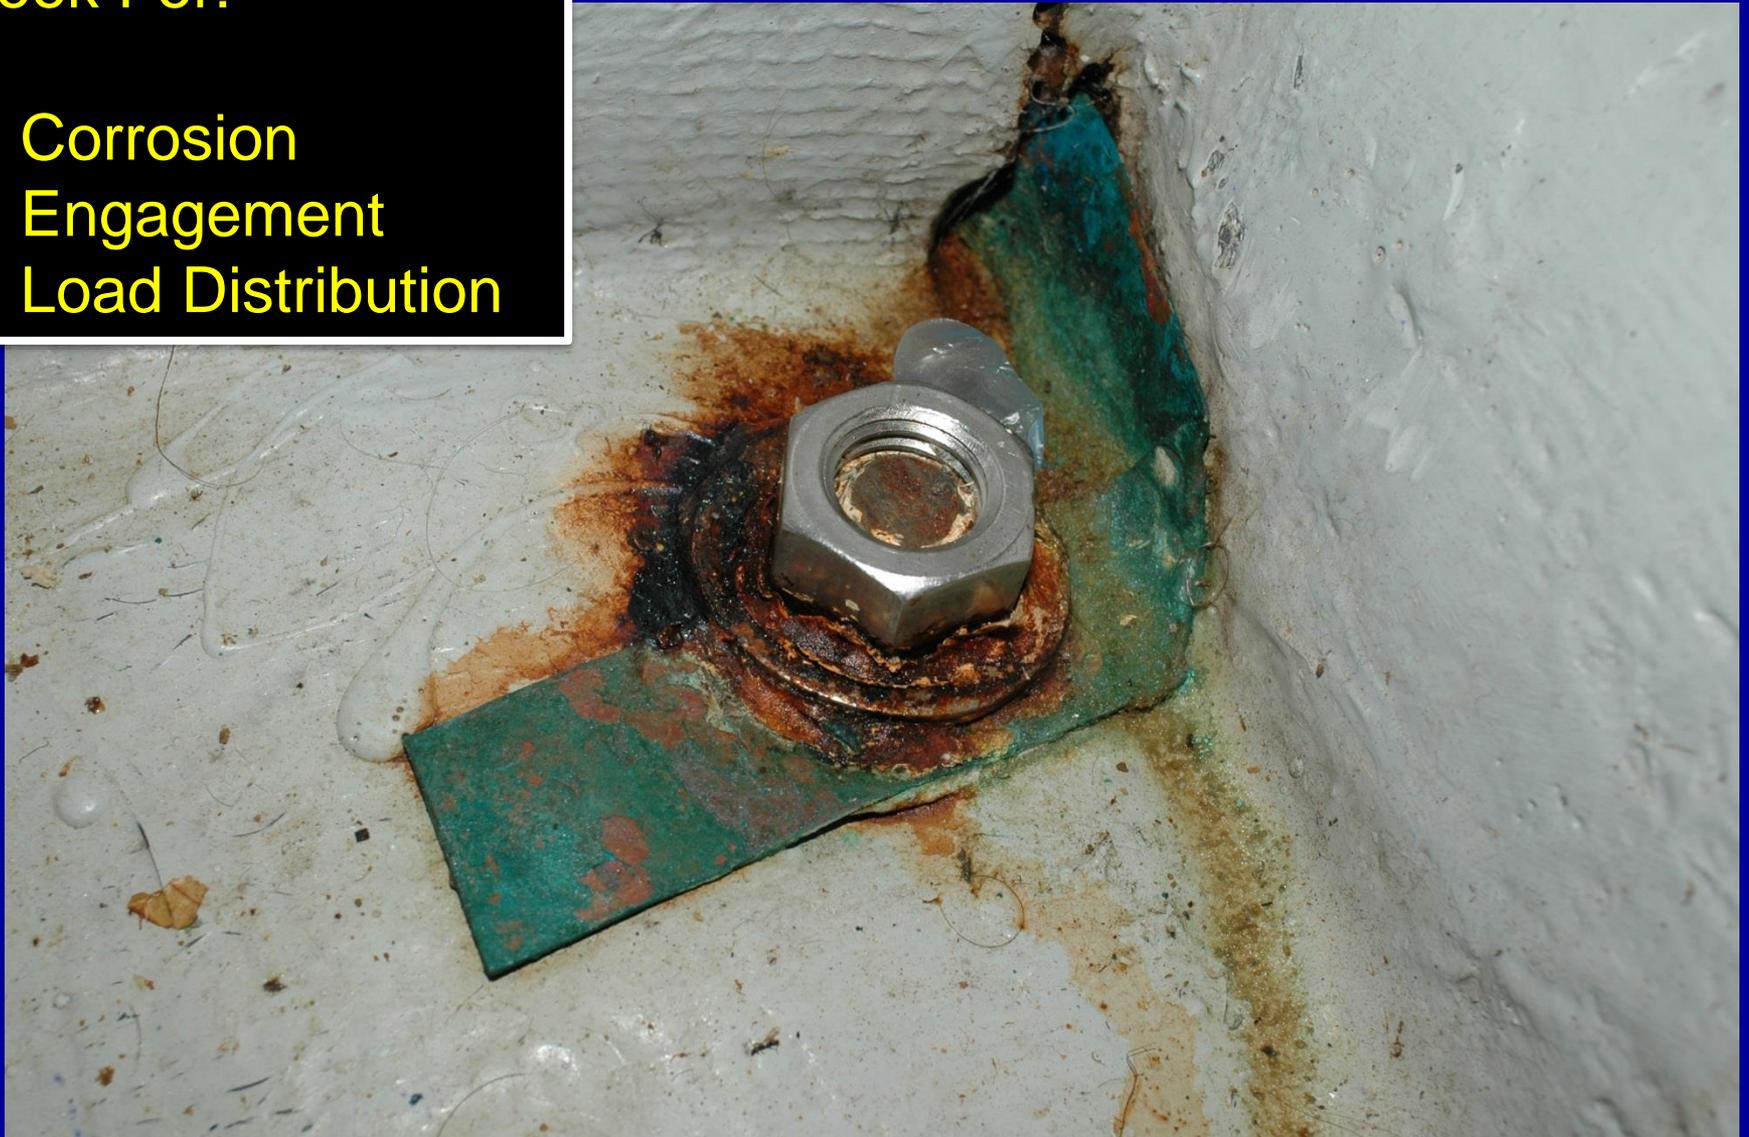
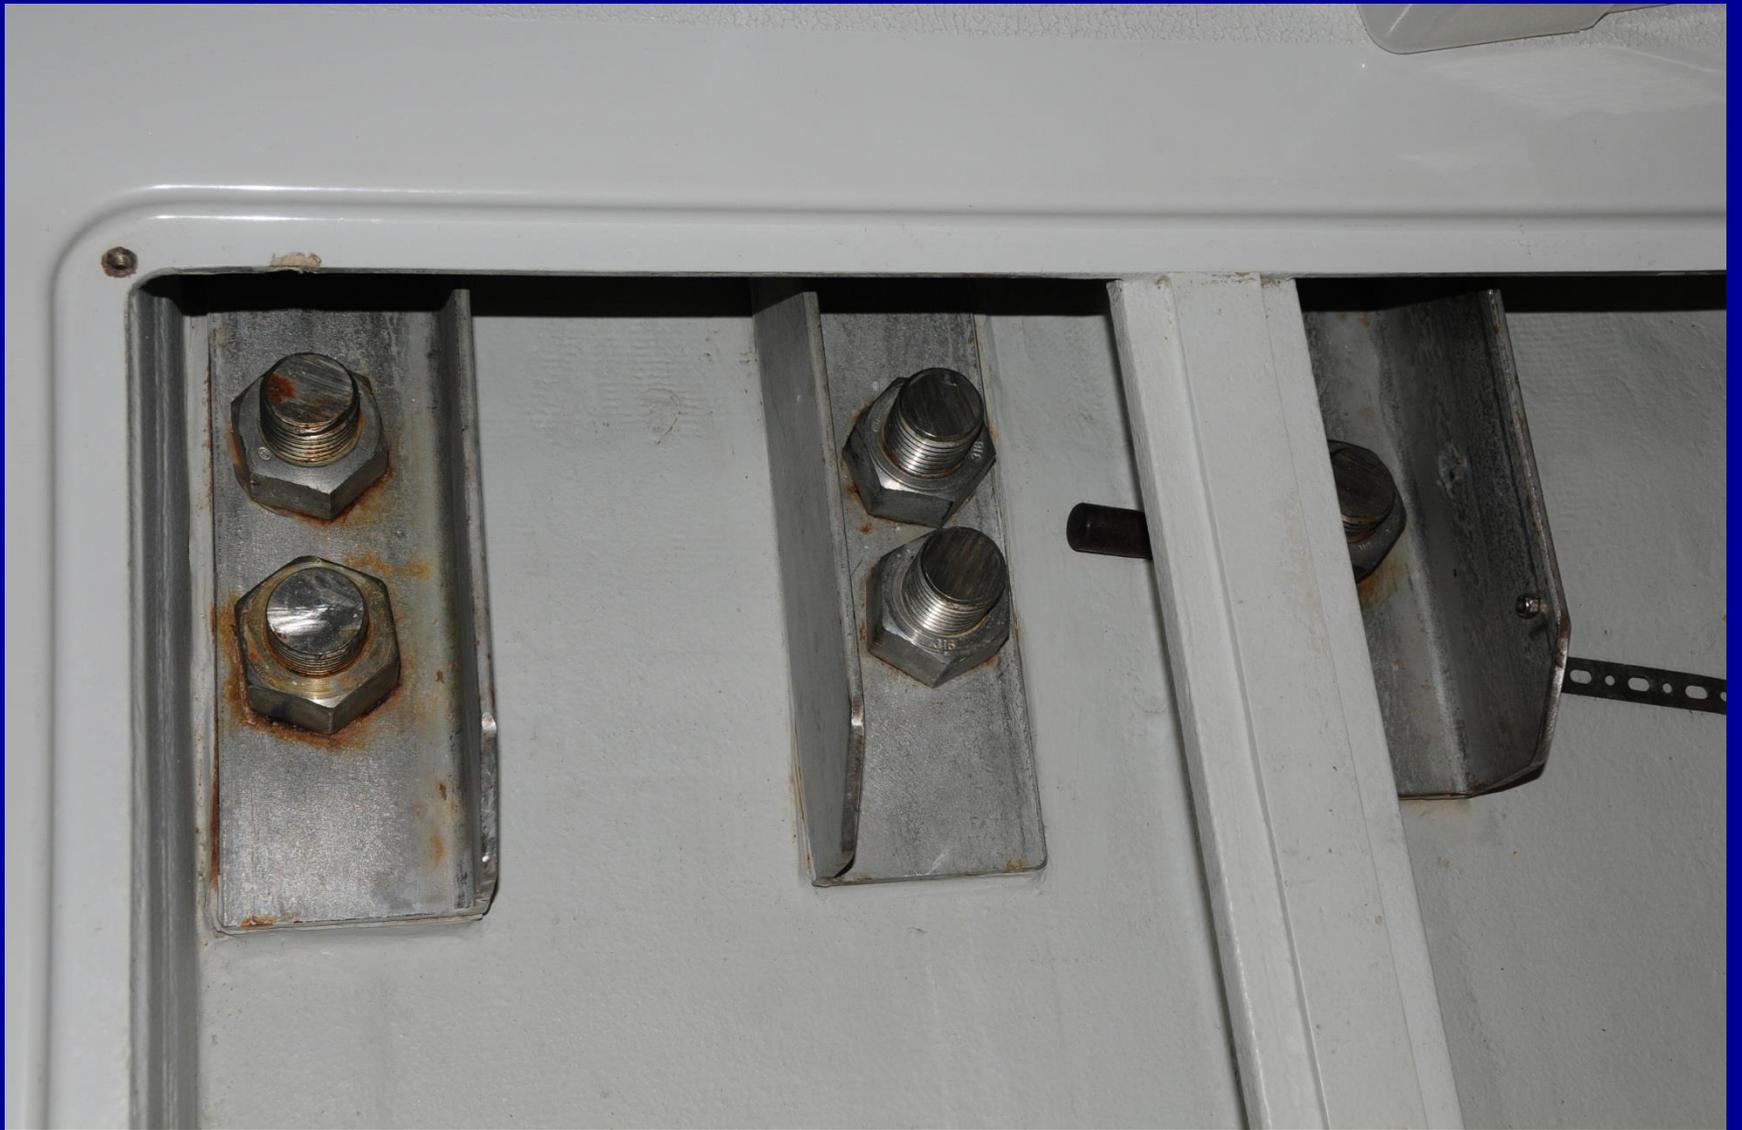
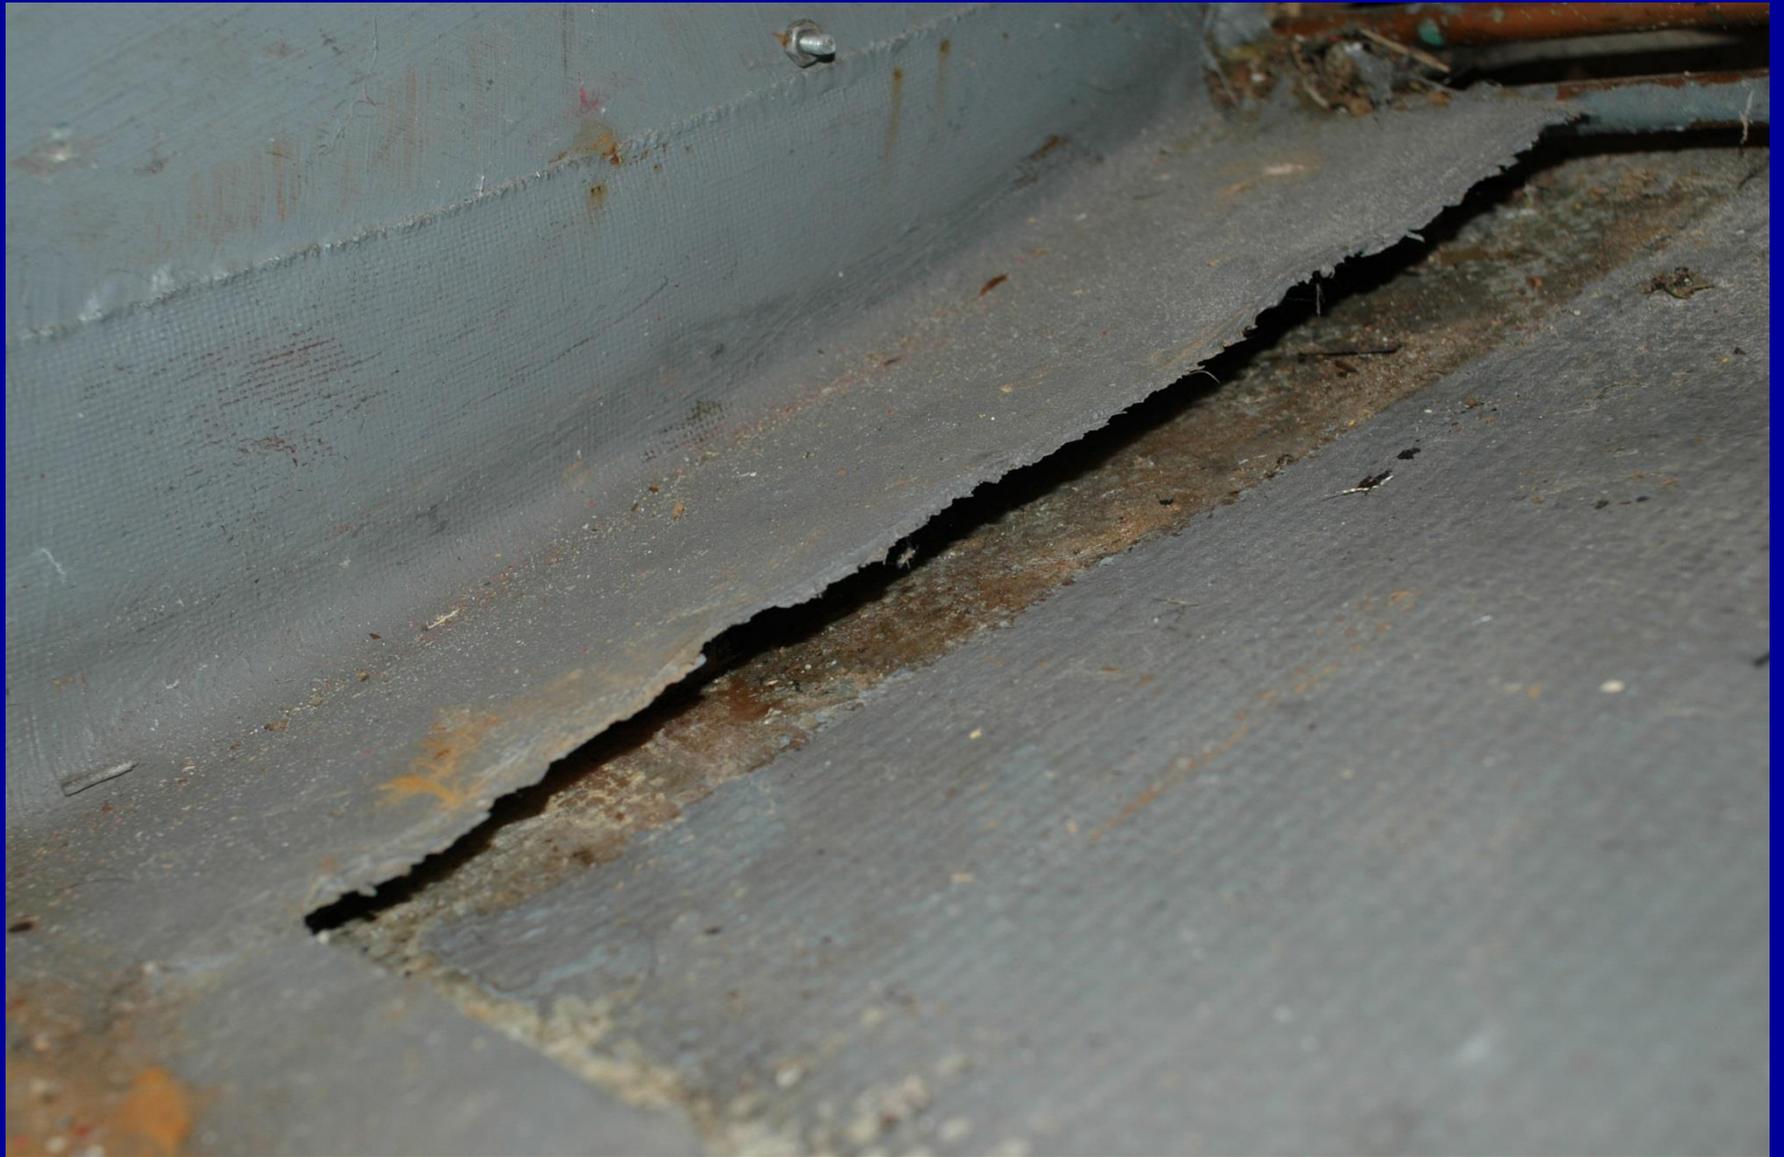
## Keel Fasteners Look For:

- Corrosion
- Engagement
- Load Distribution

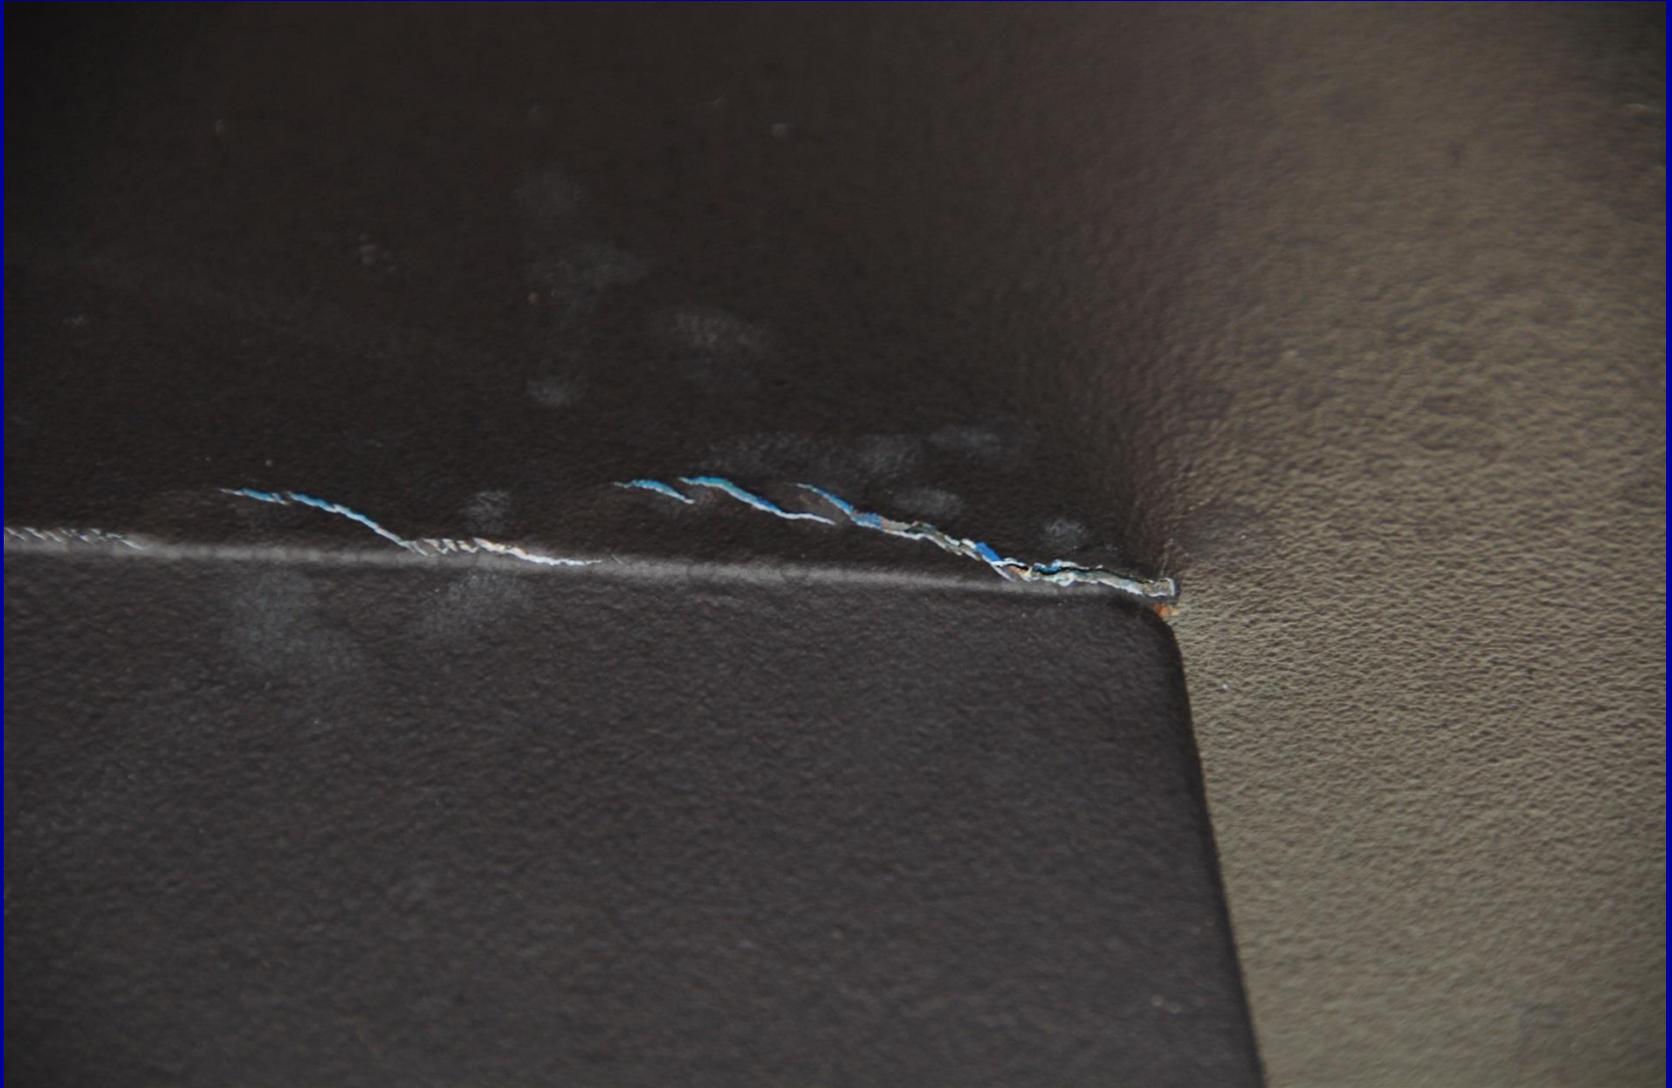
# Exterior Inspection Signs of movement

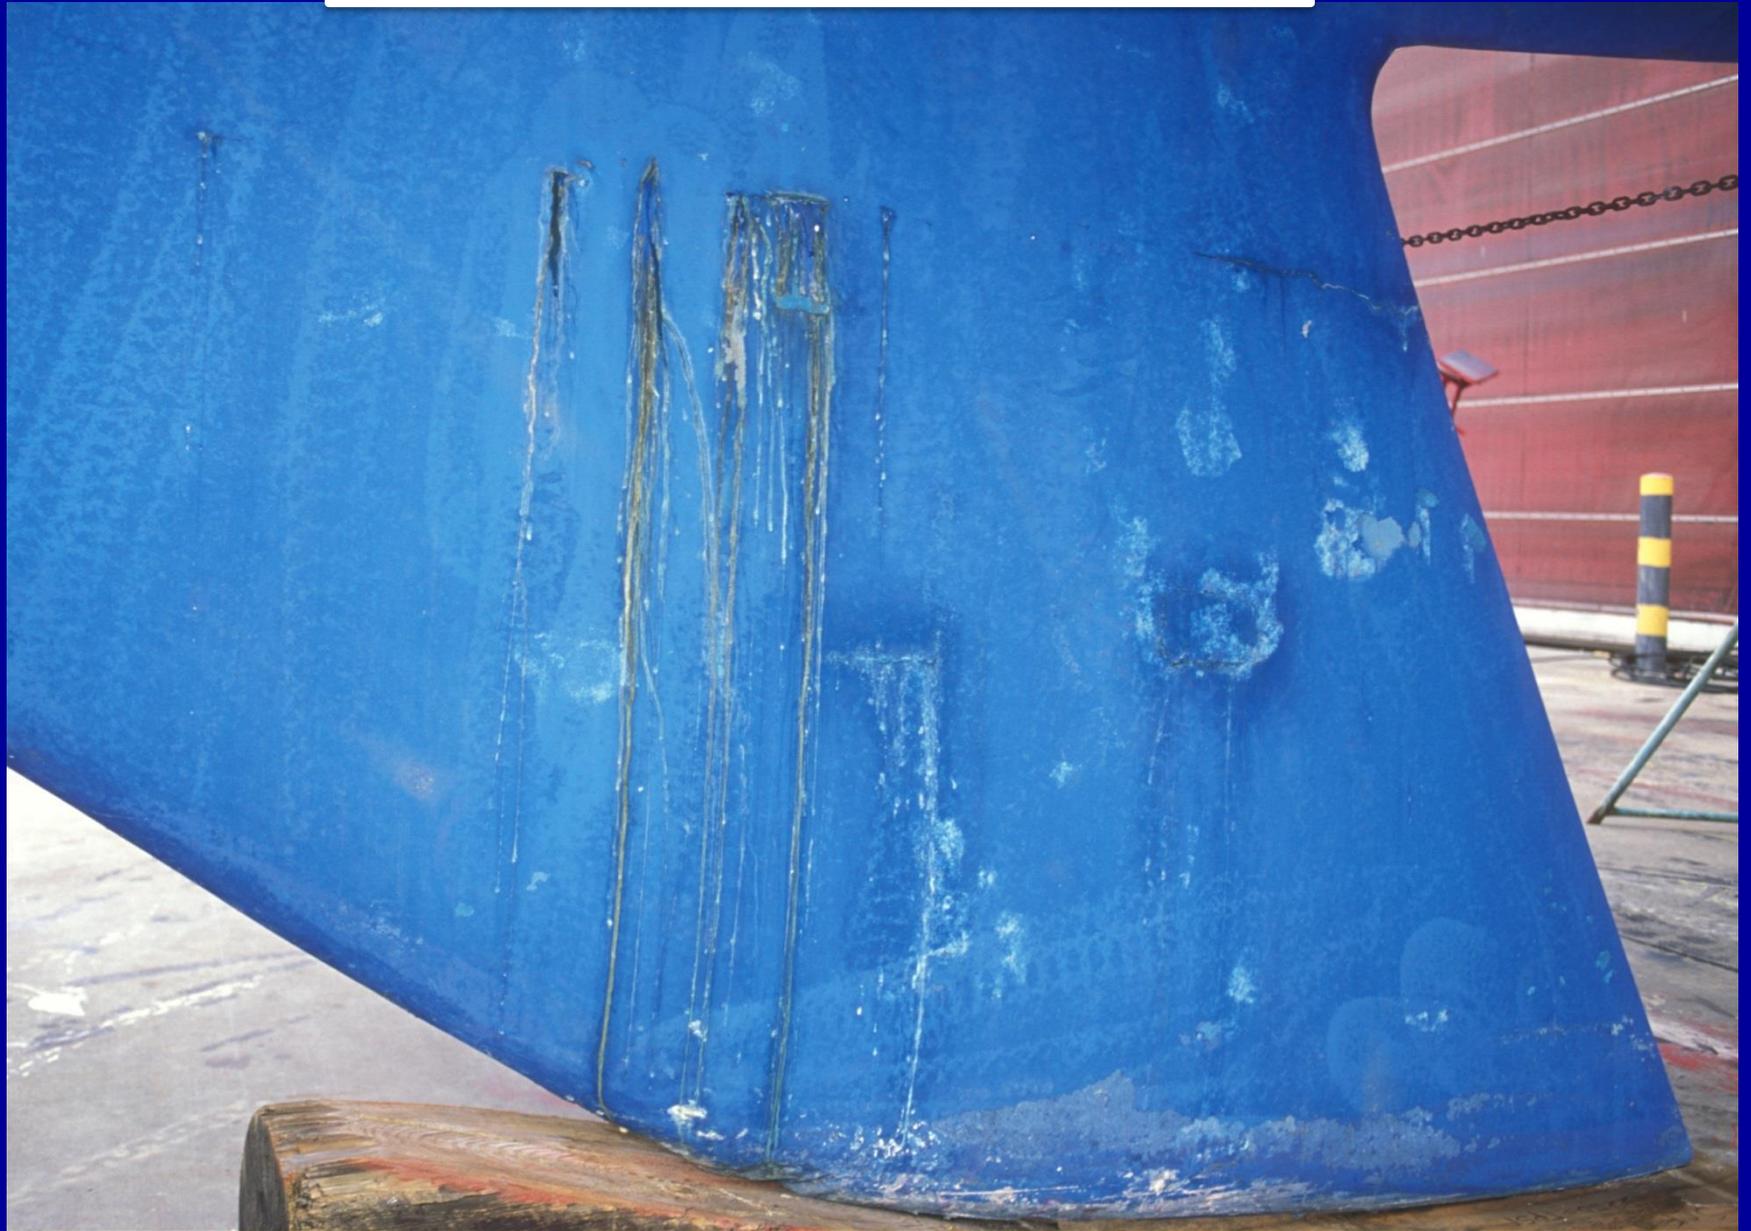
# Staining from corrosion

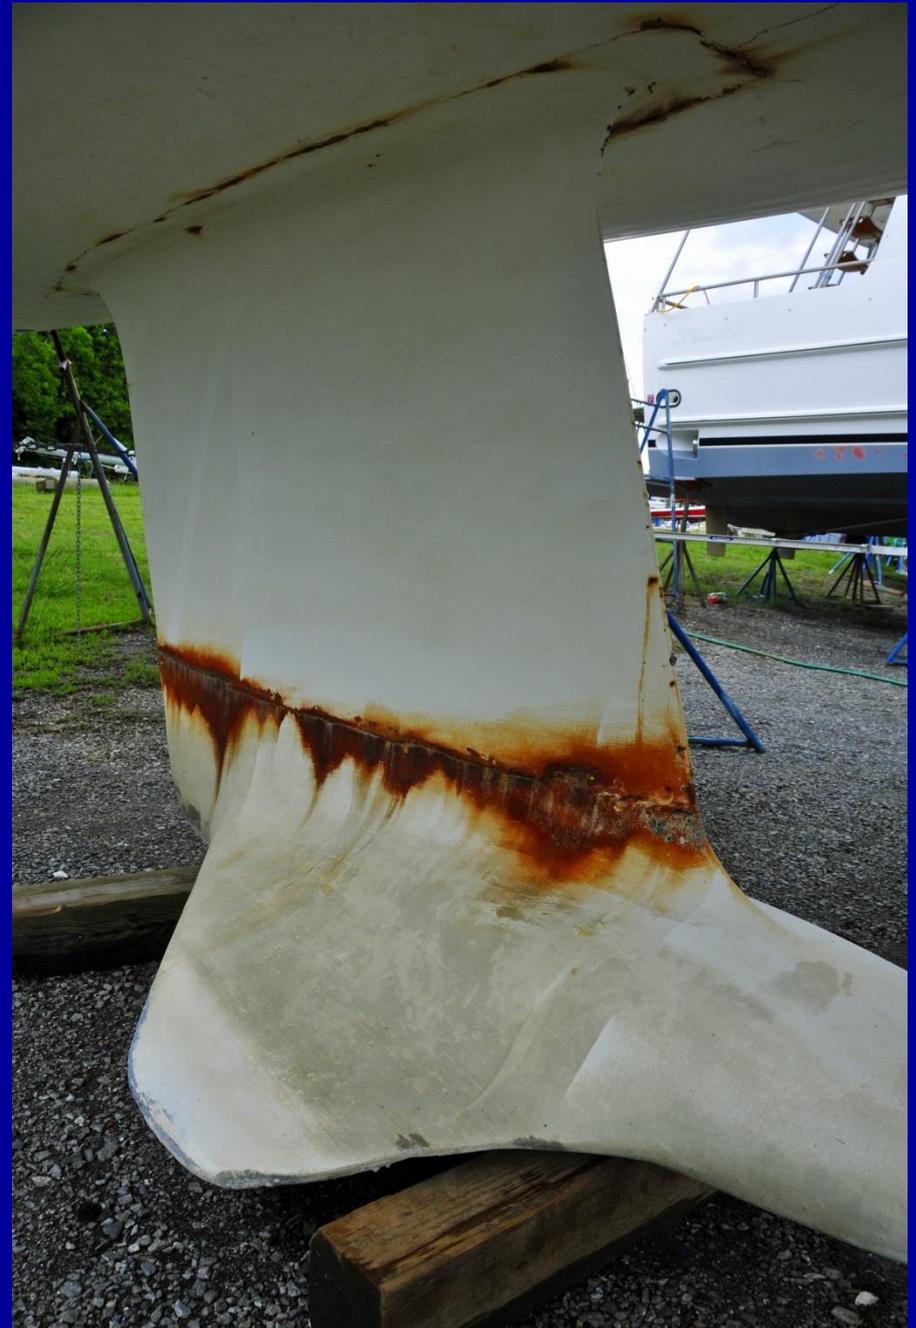
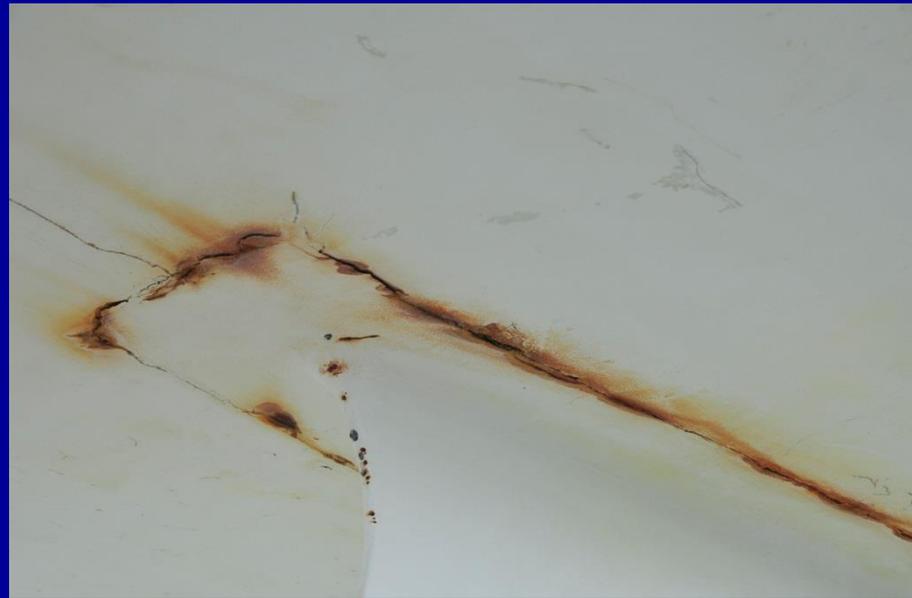
## More staining examples

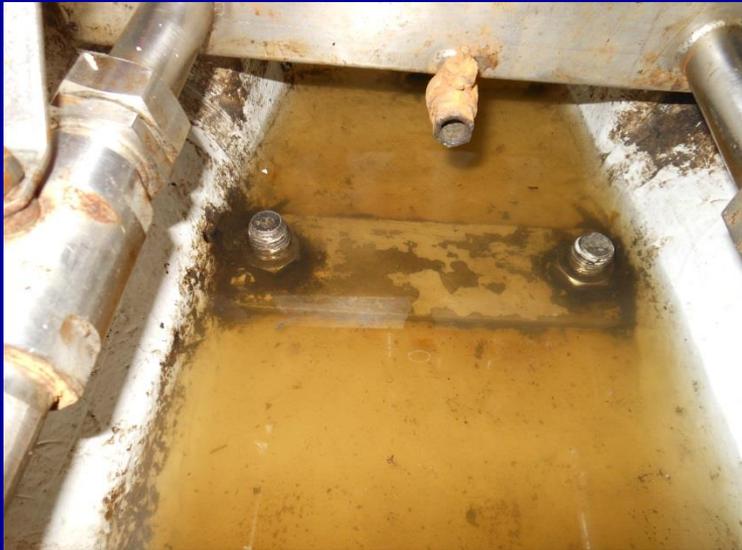
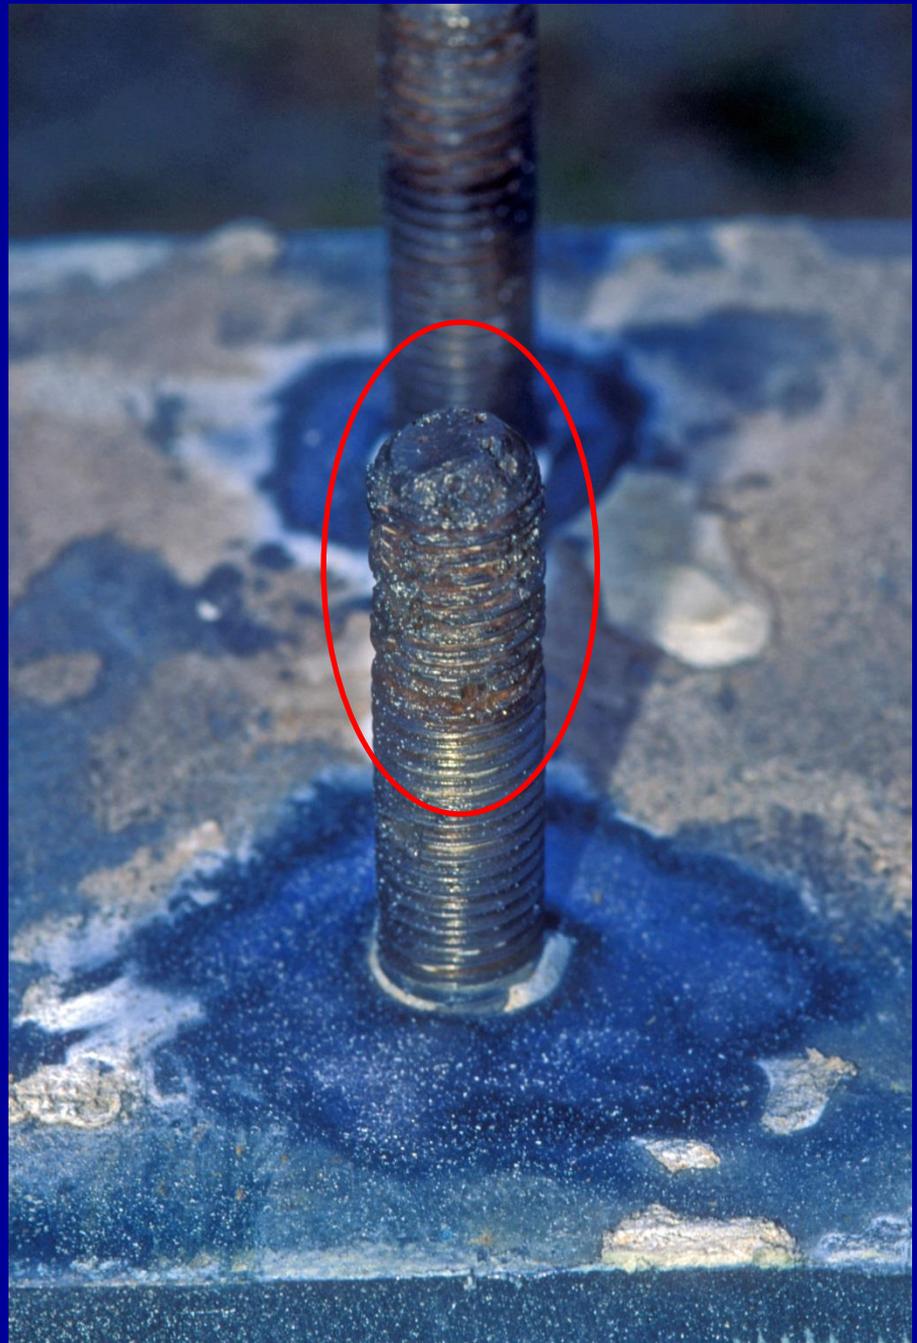
## Stainless Steel's Nemesis...

Stagnant water and the  
crevice corrosion it  
causes.

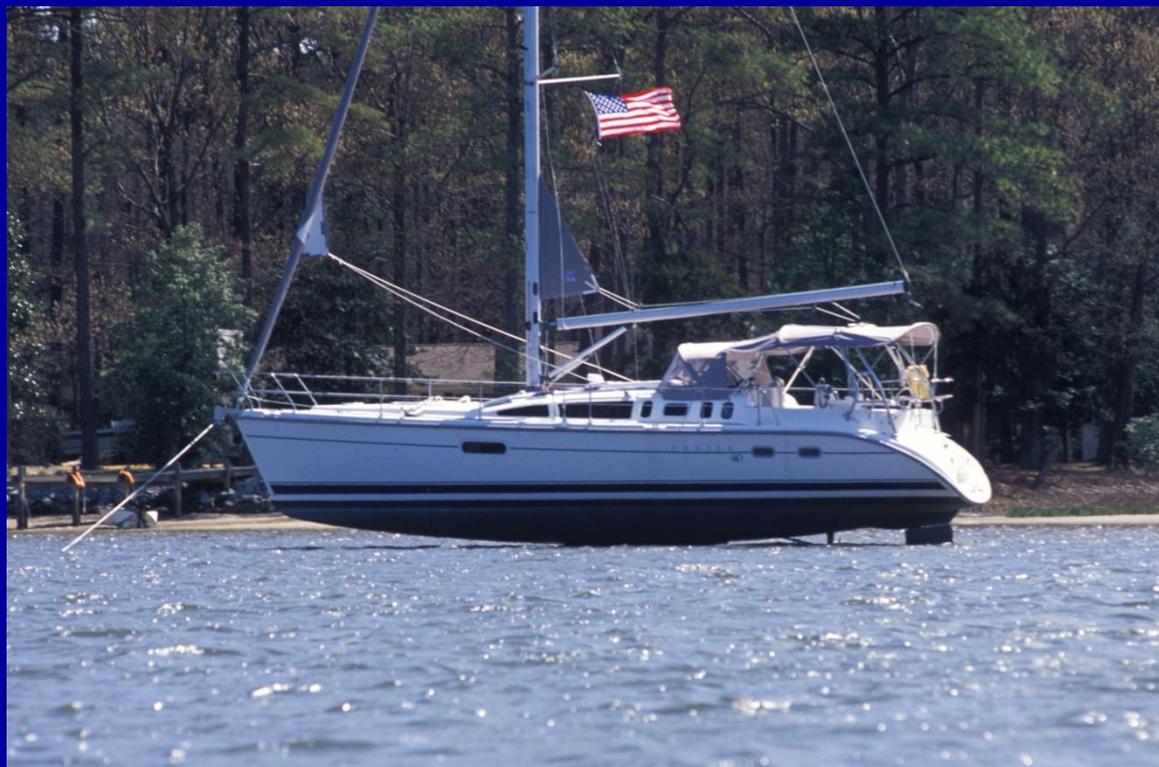
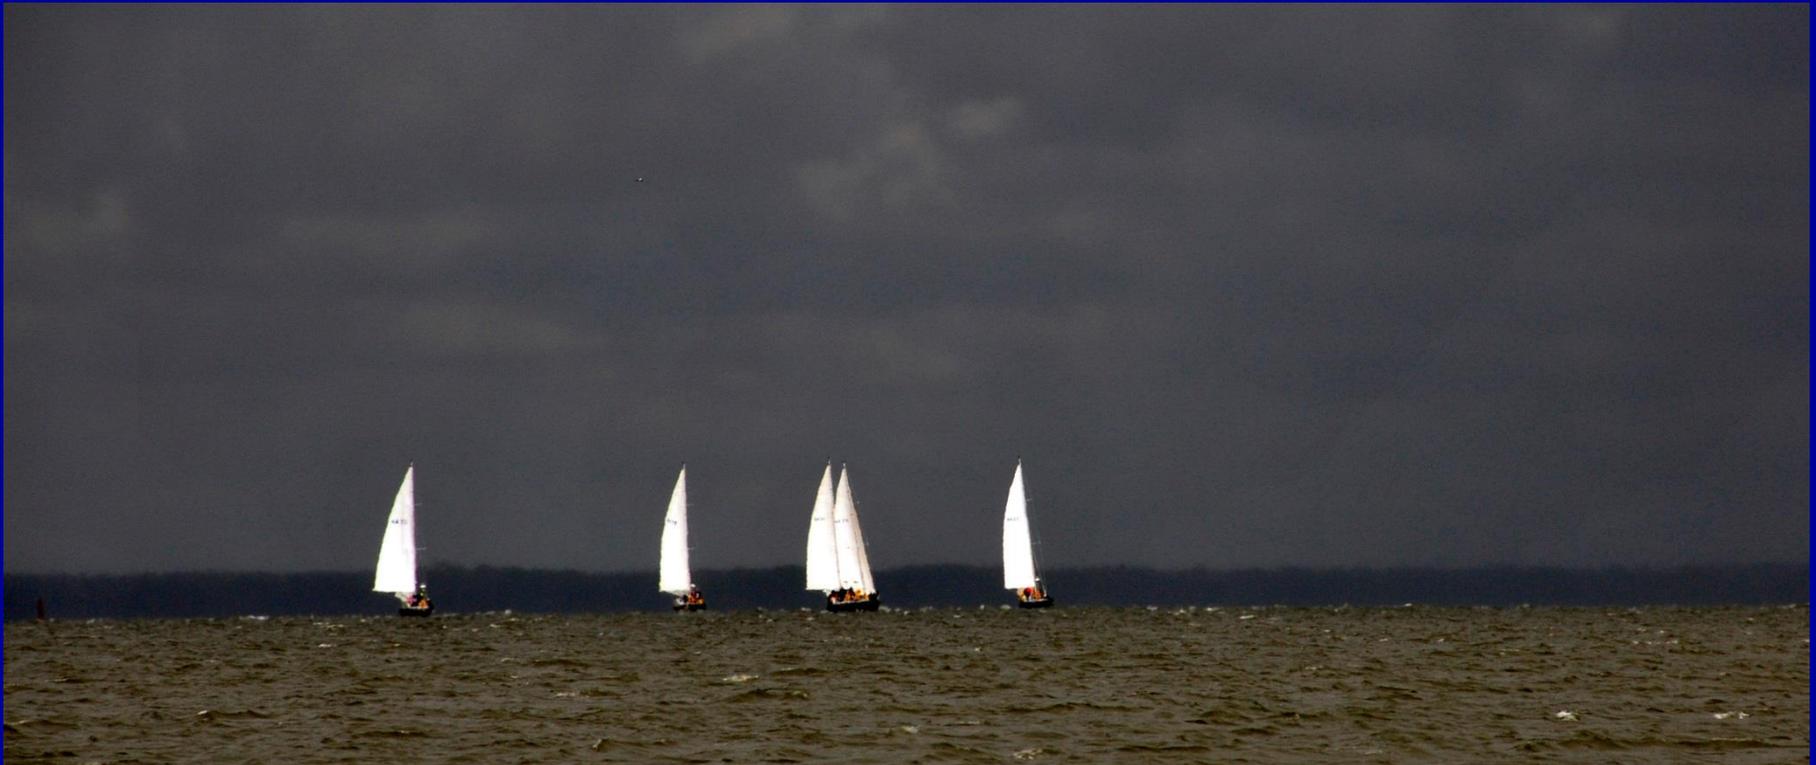
## Cheeki Rafiki MAIB Findings...

"...a combined effect of previous groundings and subsequent repairs to its keel and matrix (or lining) had possibly weakened the vessel's structure where the keel was attached to the hull."

"It is also possible that one or more keel bolts had deteriorated"

"A consequential loss of strength may have allowed movement of the keel, which would have been exacerbated by increased transverse loading through sailing in worsening sea conditions."
